西トップ寺院の保存科学的研究

Research on Conservation Science at Western Prasat Top

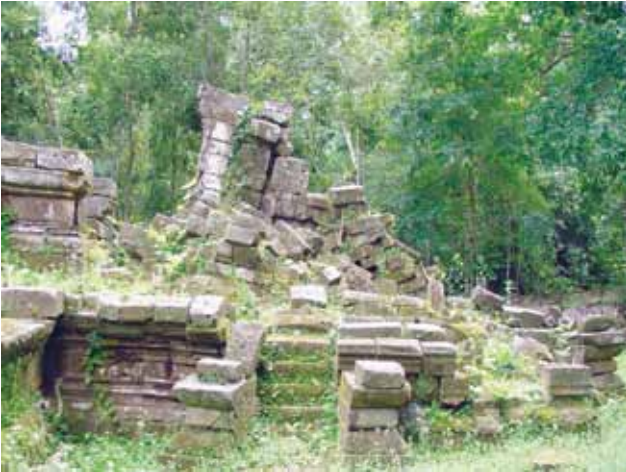
Deterioration of stone material is likely one of the causes of the collapse of western Prasat Top. Especially the deterioration of laterite is a problematic, which is a major fabric for the monument's lower structure. We carried out a strength test by Schmitt Hammer Type P for the major fabrics of the monument including sandstone and laterite, and revealed that the strength of laterite was significantly low comparing to that of sandstone, which is a major material for the upper structure (see table on next page). It is probable that the loading of the upper structure made by sandstone causes the fracture of the lower structure made by laterite.

崩壊の著しい北祠堂
Notably crumbling North Tower

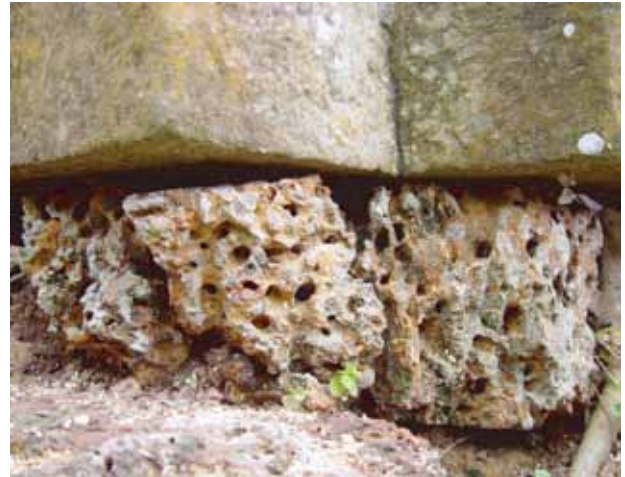
西トップ寺院の建物の崩壊の原因のひとつとして、石材の劣化が考えられます。特に建物の基礎に用いられているラテライトブロックの劣化が問題と考えられます。そこで西トップ寺院に用いられている石材（砂岩とラテライト）に対してP型シュミットハンマーを用いた強度実験をおこなったところ、建物本体を構成する砂岩に比べてラテライトの強度が著しく低いことがわかりました（表参照）。このことから、砂岩による建物本体の加重が基礎のラテライトの破壊を引き起こしていると考えられます。

劣化したラテライト
Deteriorated laterites

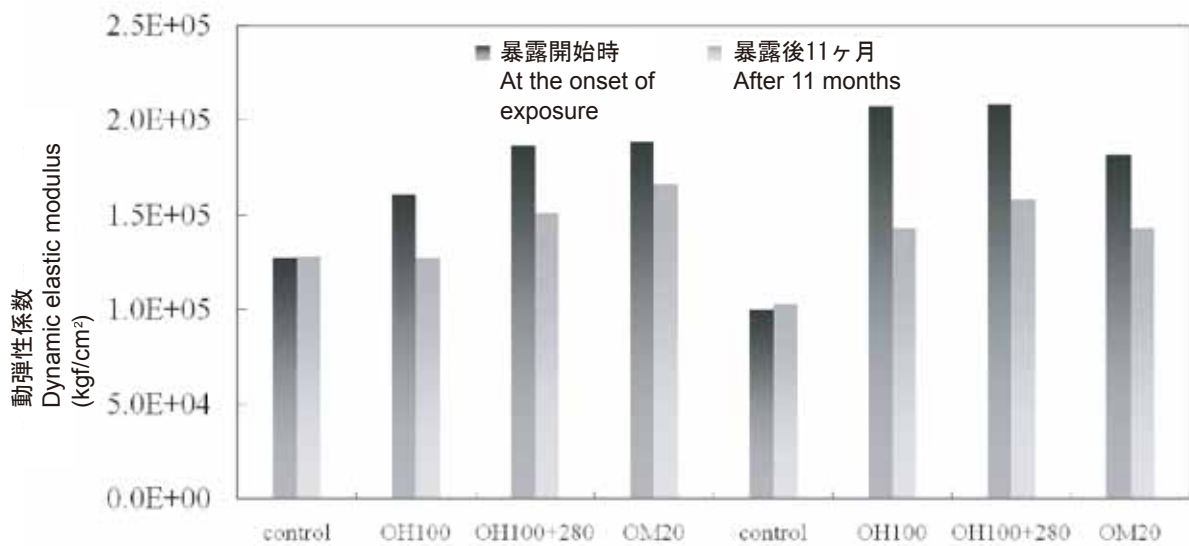
また、カンボジアの高温多湿な自然環境が石材の劣化を引き起こす要因と考えられるため、石材の強化・撥水処置を施すことが望ましいと考えられます。そこで遺跡内において複数の処置を施したサンプル石材を用いて暴露試験を実施し、超音波試験により薬剤の有効性を検討しました。その結果、11ヶ月間の暴露試験後にはいずれの試料も強度が低下していることがわかりました。過酷な自然環境にさらされることで、薬剤が比較的早く劣化するものと考えられます。今後は現地の石材を用いて様々な強化・撥水処置の有効性を検討するとともに、構造の安定性について検討をおこなう予定です。

各暴露試験体の弾性係数
Elastic modulus of samples for exposure experiment
