Chapter 1: The 10th Year of the Research and Restoration Project of the Western Prasat Top Site

Section 1: Survey of the Western Prasat Top site

Section 3: Reconstruction of the southern sanctuary

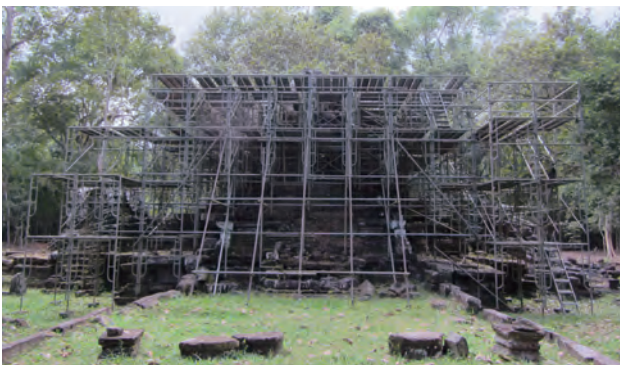
On 26 May 2008, about 40 pieces of stone fell from the east gable of the central sanctuary. It is thought that these stones were destabilised by the felling of trees, which had been growing on the top of the central sanctuary, the year before. The collapse of the stones caused further instability to the entire upper part of the central sanctuary. After urgent consultation with APSARA, and with the cooperation of the Japanese Government's International Angkor Survey (JASA), it was decided to erect a scaffold to support the main body of the sanctuary (Fig. 2).

Fig. 2 View of scaffoldings (view from the east)

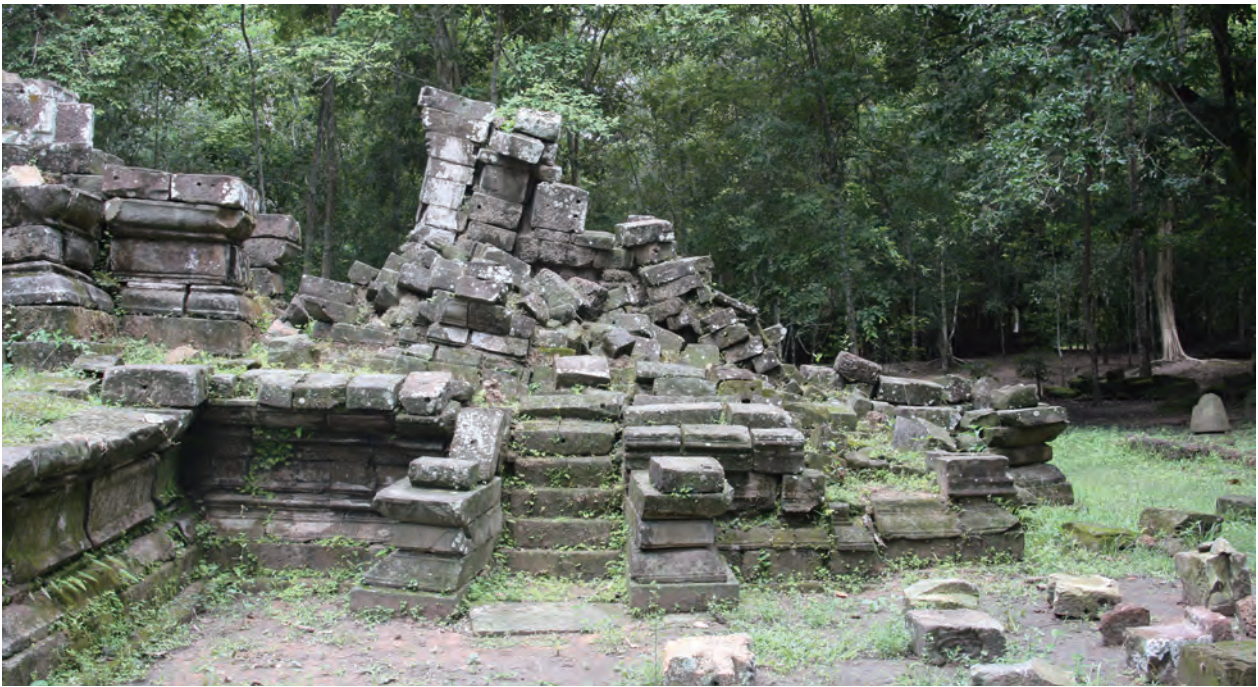
In February 2016 we started the dismantling of the northern sanctuary (Fig. 10). By March we finished the dismantling of the structure and the survey of the scattered stones north of the northern sanctuary. The whole structure of the northern sanctuary had inclined to the north and the collapse of the building frame was more severe than that of the southern sanctuary. Some stones-blocks of the building frame had collapsed and were left as they are, but most of the stone blocks of the building frame had been removed by the EFEO and placed on the ground randomly, especially on the north side of the northern sanctuary. Prior to our reconstruction work, each stone was numbered and drawn, and its original position was estimated in preparation for the reconstruction.

Fig. 10 Northern sanctuary before the reconstruction (view from the east)

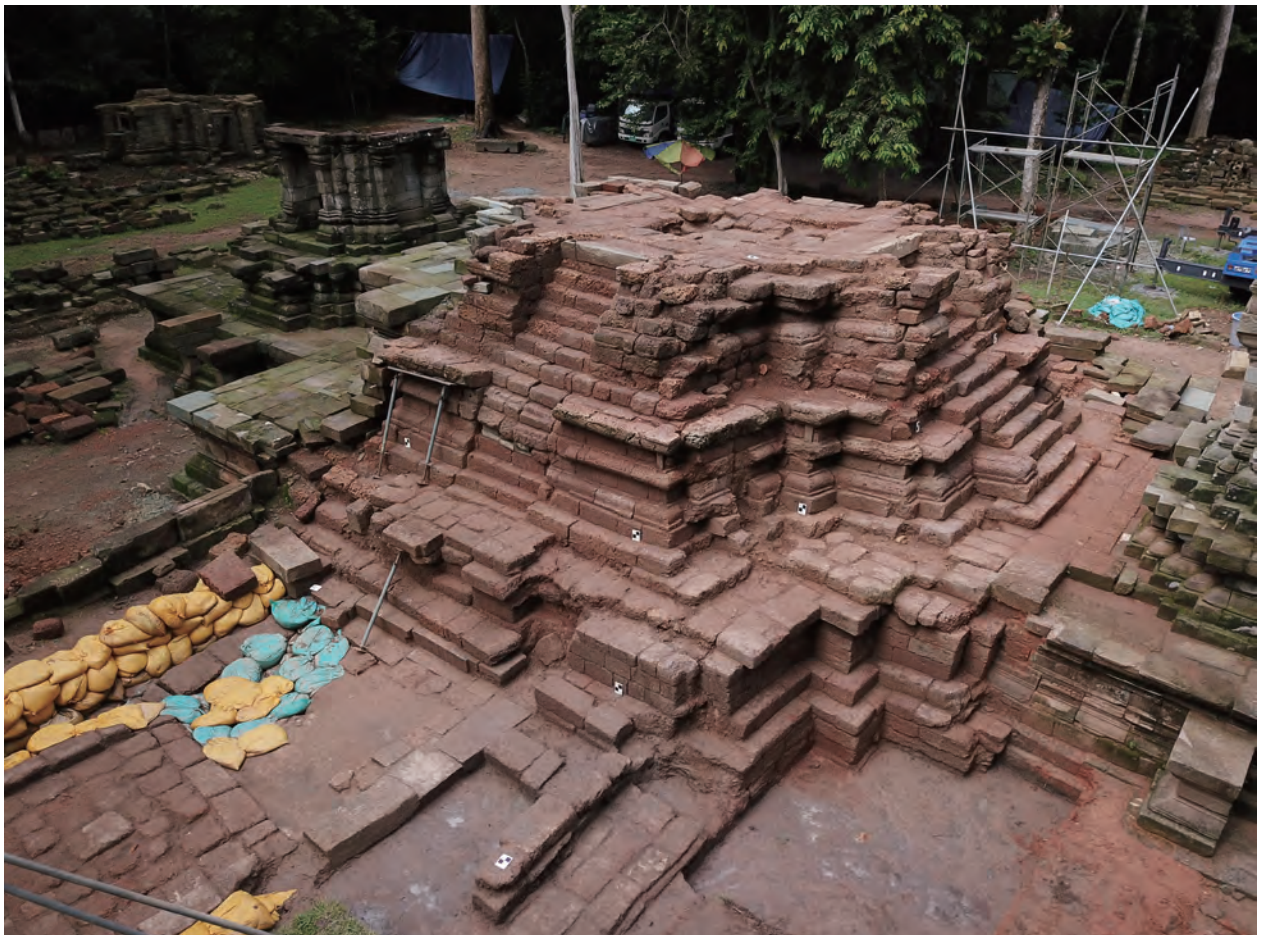
Fig. 23 Laterite platform of the central sanctuary (bird-eye view from the northeast)

As mentioned above, the laterite platform was dismantled in each quarter, and at every stage was photographed and surveyed in 3D (Fig. 23). As a result, it was found that the laterite platform, like the sandstone platform of the exterior, was composed of three tiers: upper platform, middle platform and lower platform. The upper and lower platforms were composed of simple laterite blocks while the middle platform had a carved moulding.
