Chapter 1: Research and Restoration Project of the Western Prasat Top Site

Section 1. Process of the Reconstruction

Section 2. Reconstruction of the Central Sanctuary

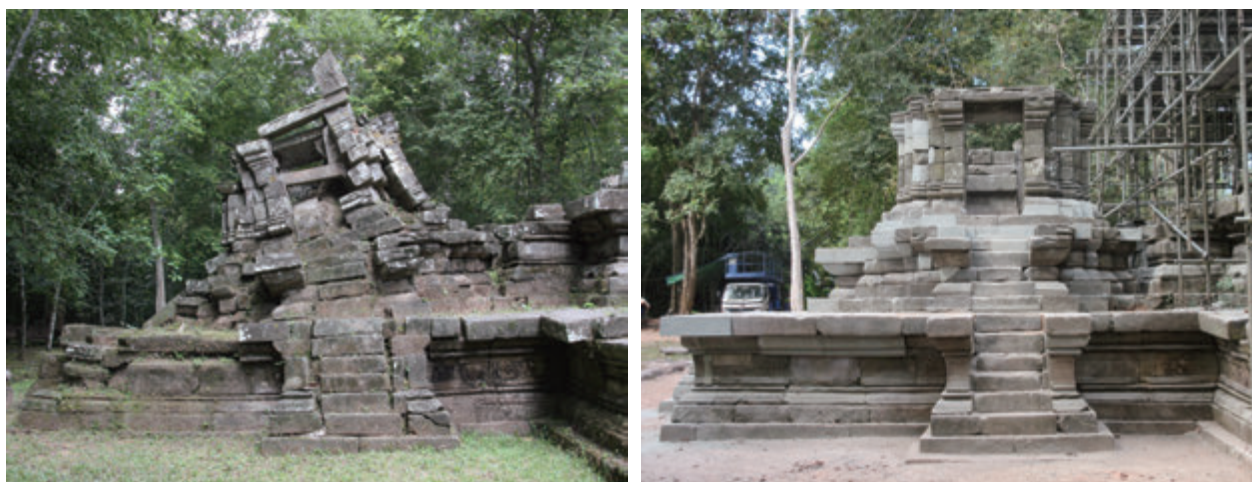
The southern sanctuary consists of the building frame, the upper platform and the lower platform (Fig.2). Most of the roof was lost and the body was tilted 19 degrees to the south. The dismantling of the structure was carried out by a process of drawing plans, numbering the stones, and dismantling one layer at a time, starting from the top. The top surface of the platform was made of sandstone paving stones, but it had sunk more than 20cm, from the centre to the south, due to unequal settlement of the associated fill. When the paving stone layer was dismantled, it was found that the foundation soil was coarse sand. When this soil was excavated, the southern staircase of an earlier platform of the central sanctuary was found in the lower platform of the southern sanctuary. After the dismantling of the lowest level of the platform, the trace of the underground foundation was confirmed from the south side of the lower platform and also the rows of stone blocks were found in the center of the foundation. From October 2014, we started to reconstruct the foundation under the platform and on 23 September 2015, we successfully completed the research and restoration of the southern sanctuary.

Fig. 2 South sanctuary before the reconstruction (left side), after the reconstruction(right side) (view from the east)

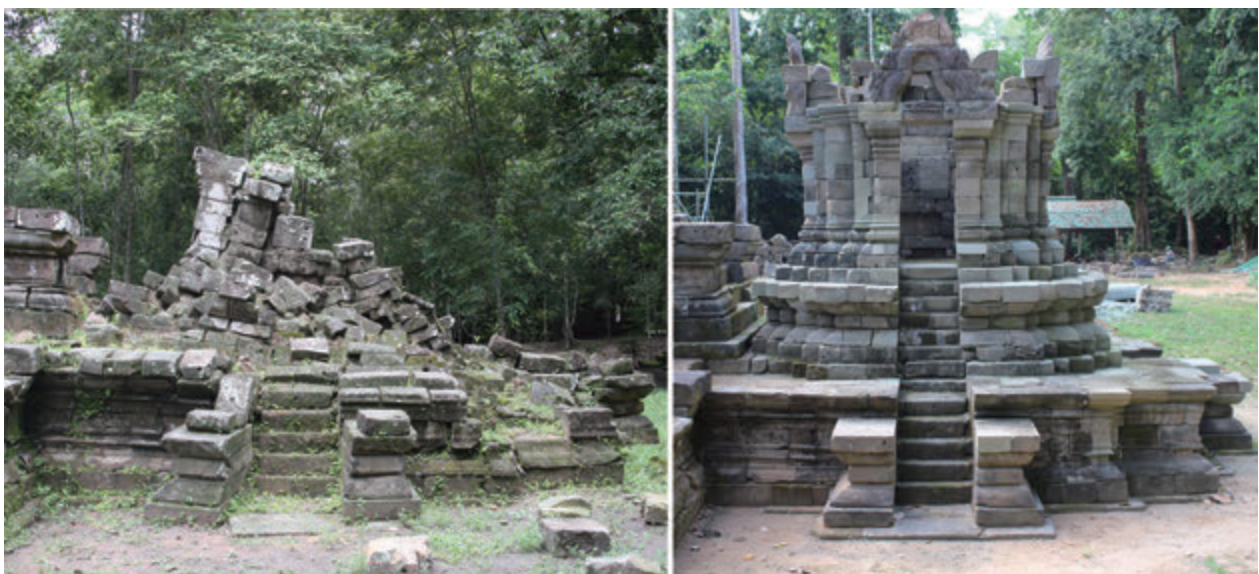
In February 2016 we started the dismantling of the northern sanctuary (Fig.3). By March we finished the dismantling of the structure and the survey of the scattered stones north of the northern sanctuary. The whole structure of the northern sanctuary had inclined to the north and the collapse of the building frame was more severe than that of the southern sanctuary. After the dismantling of the building frame was completed, we started to investigate the platform of the sanctuary.

Fig. 3 North sanctuary before the reconstruction (left side), after the reconstruction(right side) (view from the east)

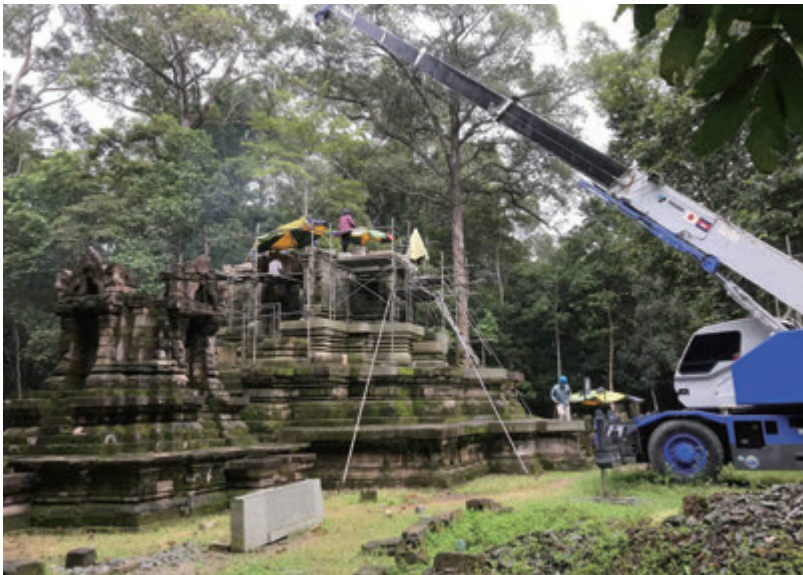
Fig. 8 Reconstruction situation of Central sanctuary (view from the northwest)

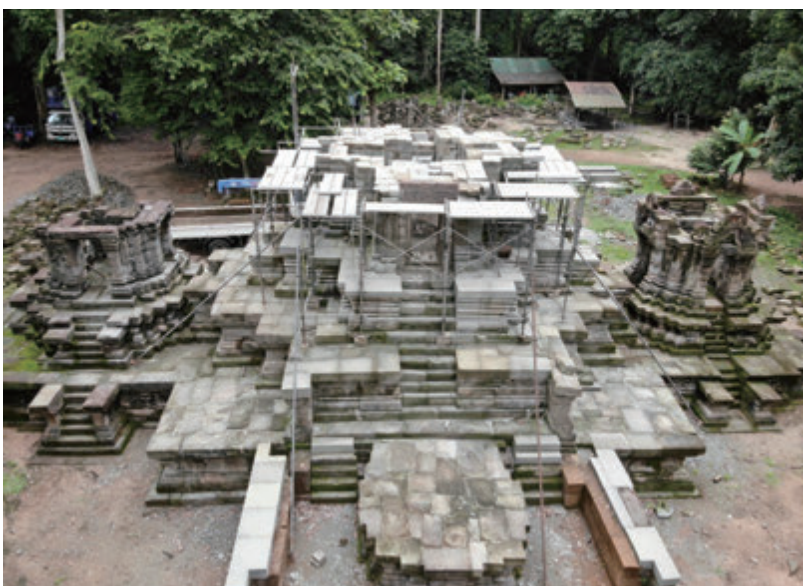
Fig. 9 Reconstruction situation of Central sanctuary (view from the east)

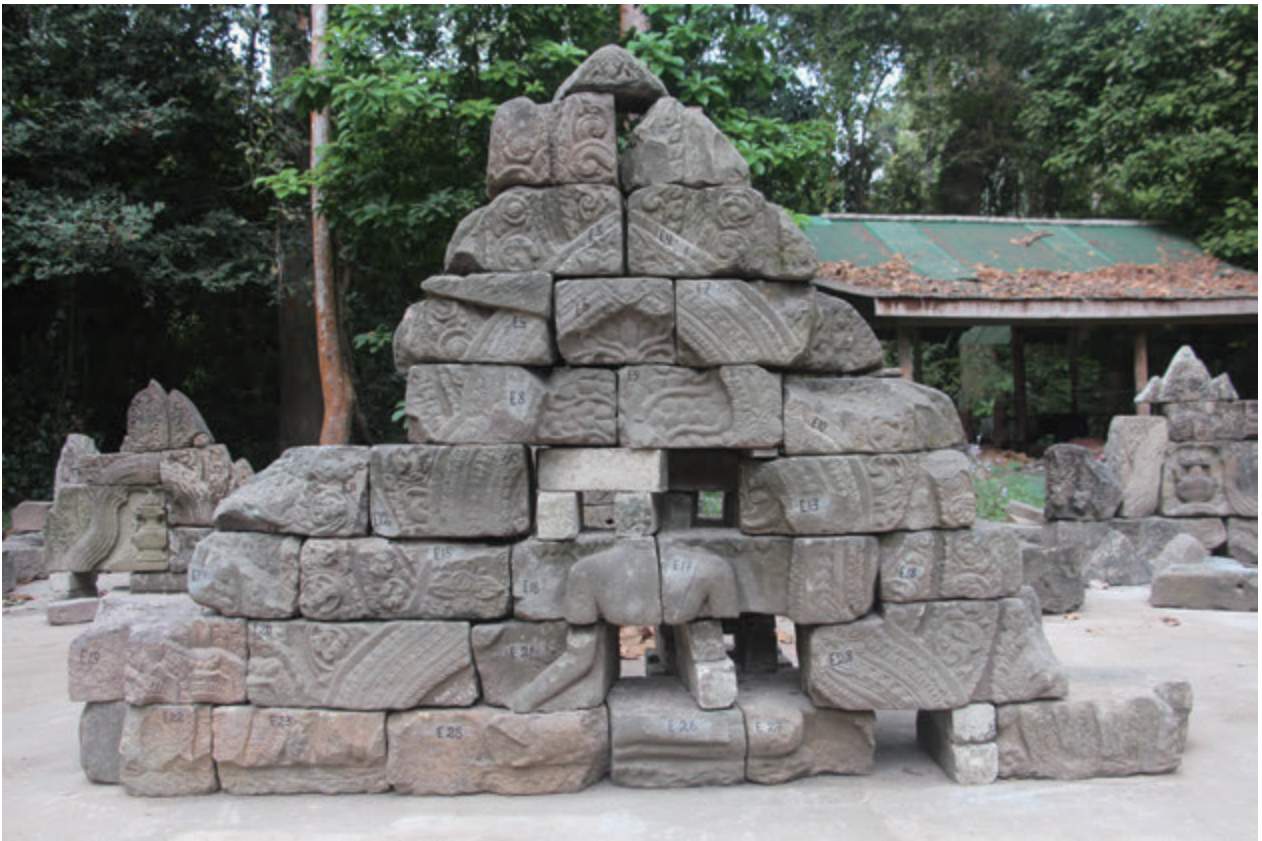
East pediment (Fig.13)

The first pediment, like other pediments found at Angkor, is composed of a carved image of the subject within a niche divided by a band of decoration. At each end of the pediment, there is a relief of five heads of Naga wearing crown-like ornaments, which is the same on all four sides of the first pediment. The east pediment is the only one that can be seen in its original position in old photographs taken by EFEO (Fig. 10). In the niche of the pediment, a seated Buddha image in the *māravijaya* is shown. Above the head of the seated Buddha is a representation of a leaf of the Bodhi tree, with the leaf pattern continuing to the shoulder of the seated Buddha. The stone materials for the head, body and base of the seated Buddha image have not been confirmed at present.

Fig. 13 Trial reassembly of the first east pediment

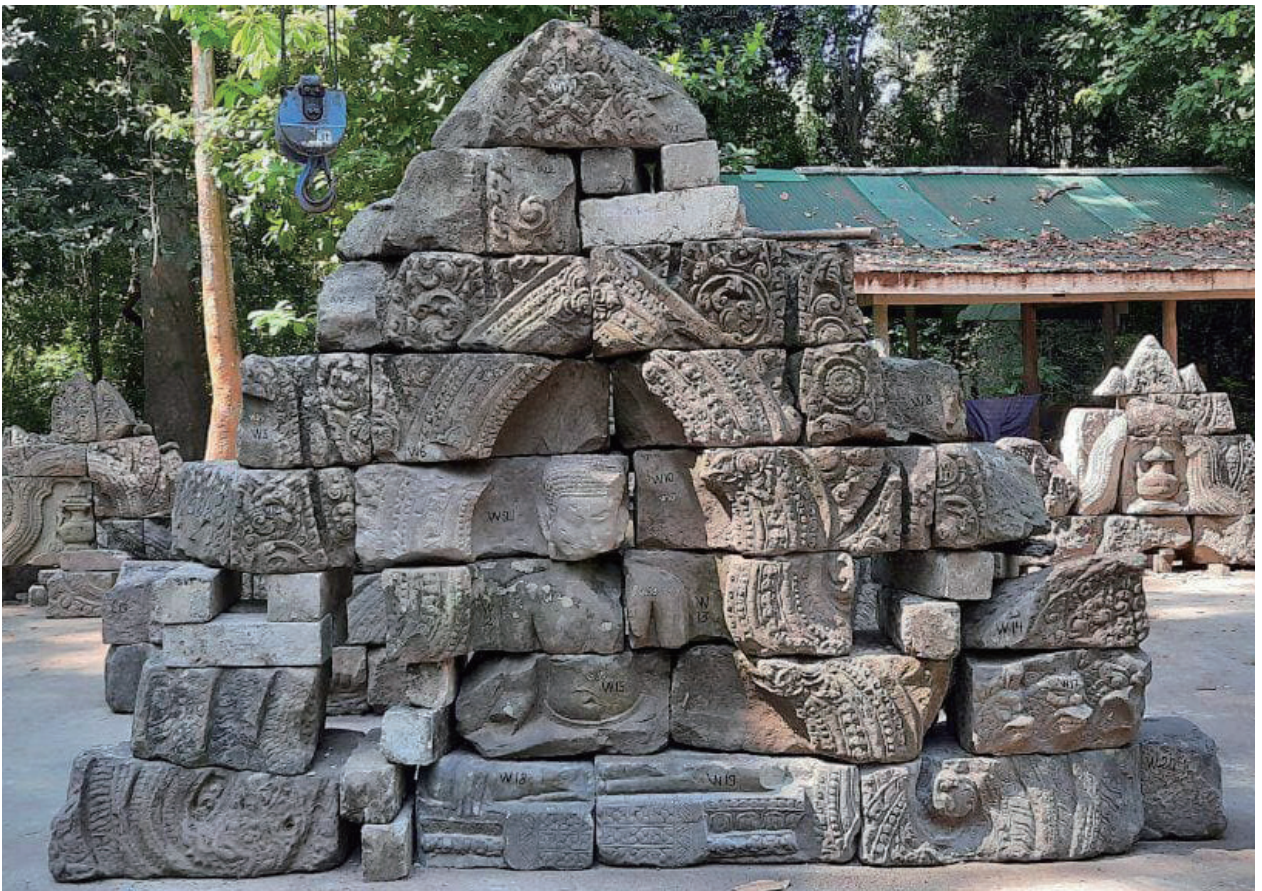
West pediment (Fig.14)

The pediment on the west face could not be seen in old photographs, but we were able to reconstruct it almost completely by finding the relevant parts among the scattered stones. Inside the niche is a seated Buddha image in *māravijaya*, but without the Bodhi tree seen on this pediment. The face is obscured in places by wear and tear, but the eyes are long and slanted, and the eyebrows are slightly arched. The pedestal on which the seated Buddha sits is composed of three layers of patterned bands. The upper layer is decorated with a flower design, the middle layer with a double-petalled lotus design, the lower layer with a lotus bud-shaped design, and in the centre of the pedestal is a square decoration with a floral motif.

Fig. 14 Trial reassembly of the first west pediment

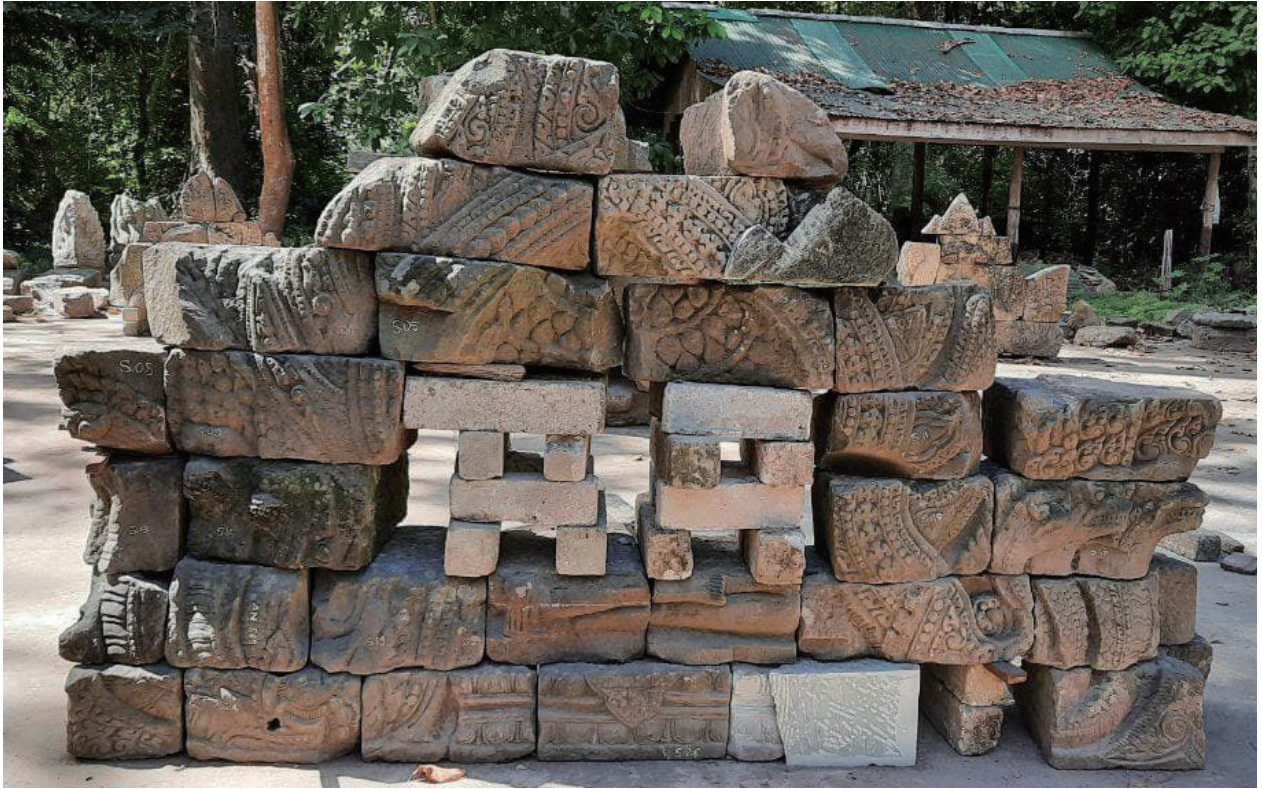
South pediment (Fig.15)

The south pediment was also not recorded in the old photographs. For the legs of the seated Buddha image, we have been able to find the appropriate stone material, but unfortunately we have not been able to find any stone material above the body of the seated Buddha. From the expressions on the legs, it can be assumed that the seated Buddha was represented in *māravijaya*, as on the other sides. The upper part of the seated Buddha image is carved with leaves of the Bodhi tree. The pedestal is decorated with upwards lotus petals in the upper part and downwards lotus petals in the lower part, and the central part of the pedestal is adorned with floral designs in the form of an inverted triangle.

Fig. 15 Trial reassembly of the first south pediment

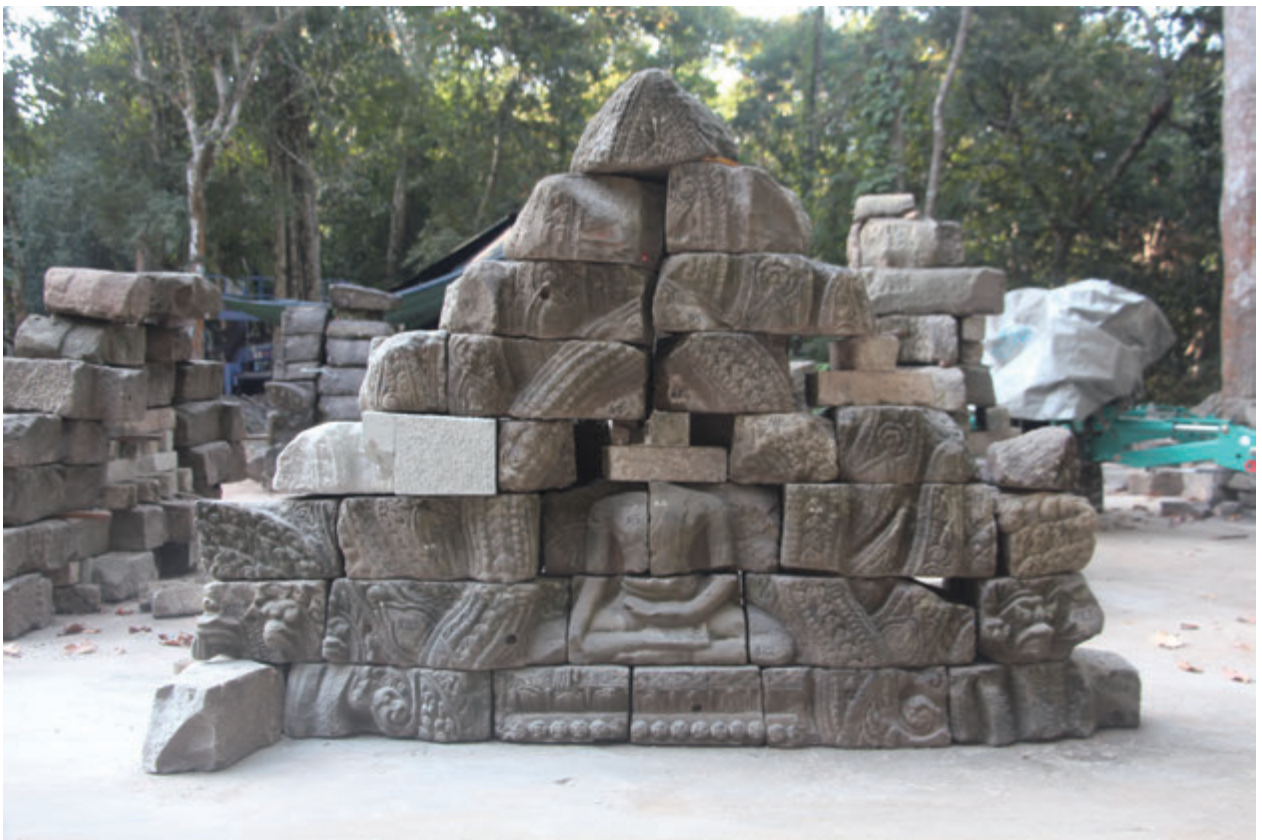
North pediment (Fig.16)

Although the north face could not be confirmed by old photographs, it could be almost completely reconstructed except for the head of the seated Buddha image. The seated Buddha image sits on a pedestal in *māravijaya*. As in the west face, there is no representation of a bodhi tree on the upper part of the seated Buddha image. The pedestal has a similar structure to that of the west face, with three layers of patterned bands: a flower patterned band on the upper layer, a double-petalled lotus band on the middle layer, and a lotus bud band on the lower layer. There is no representation of fabric or ornamentation as seen on the western pediment.

Fig. 16 Trial reassembly of the first north pediment
