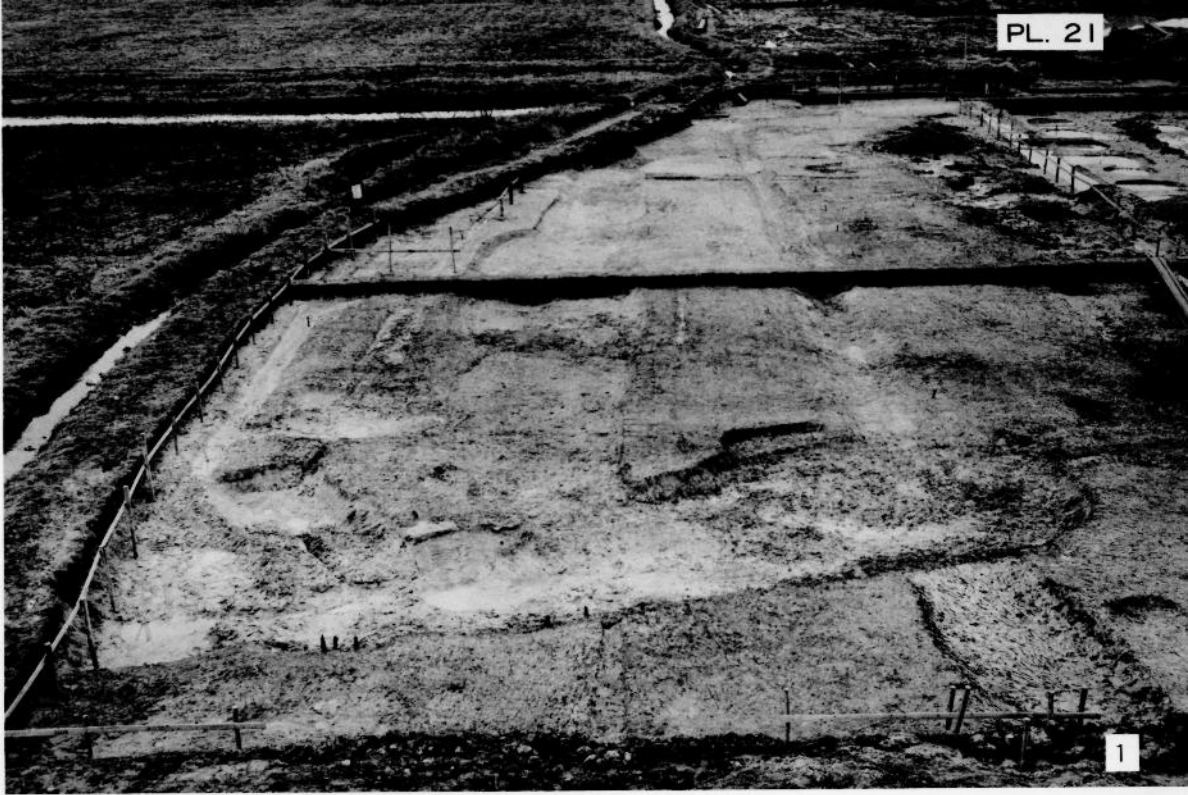
1. 馬寮東官衙西限築地  
SA6150 を切る溝  
SD6155 北から

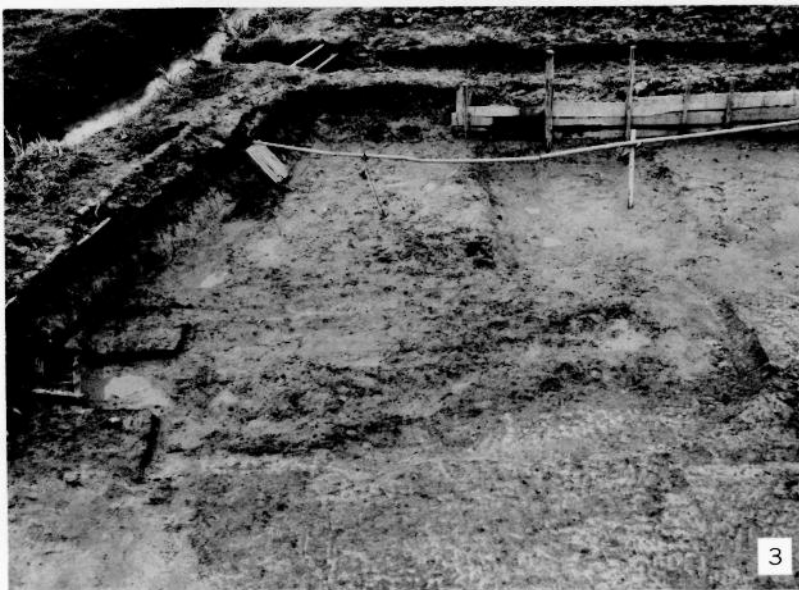
1. SB6165・6169・  
6170等重複状況  
南から

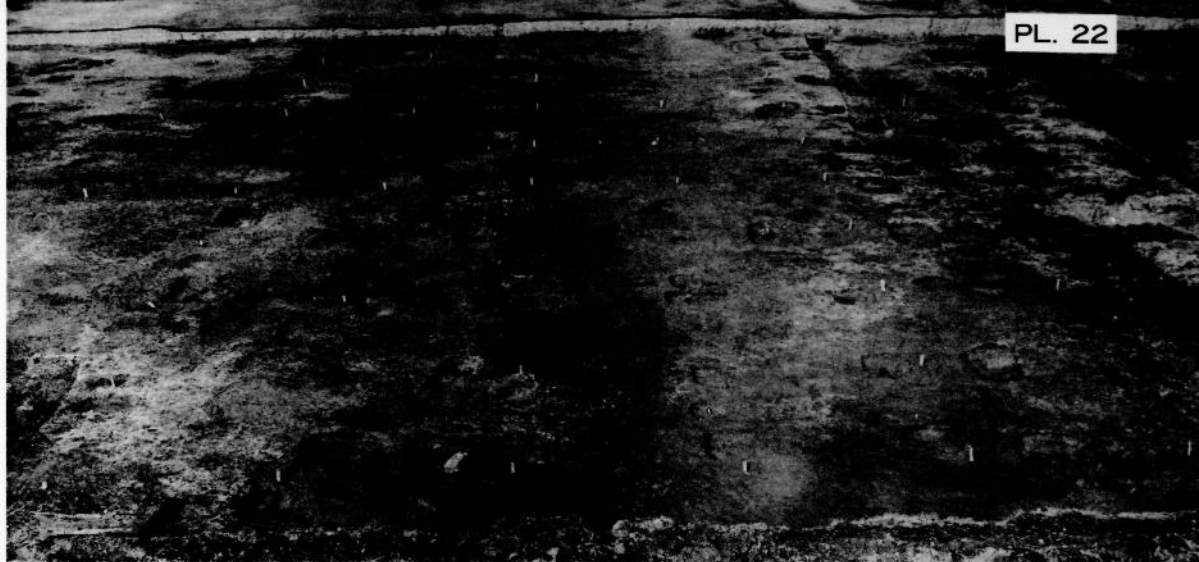
2. 同上 北から

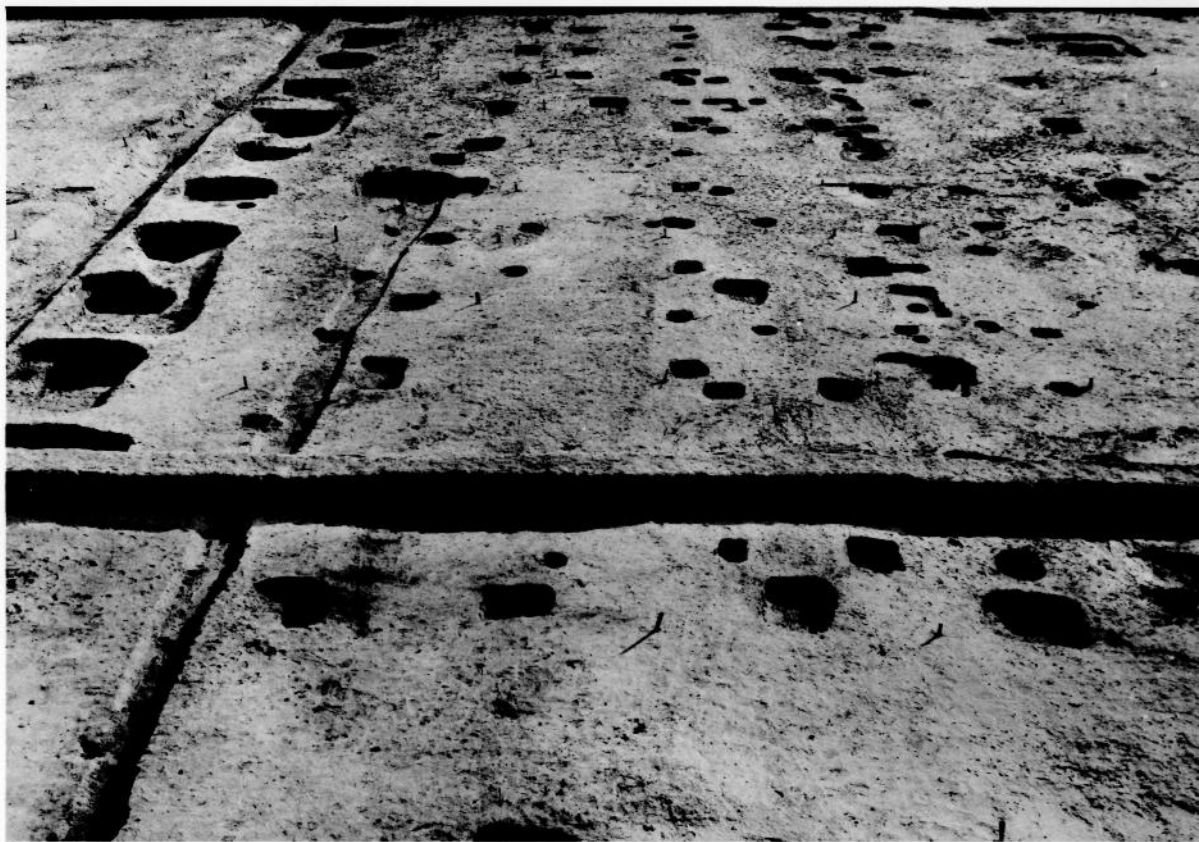
3. SB6171・6172・  
6173・6175  
重複状況 北から

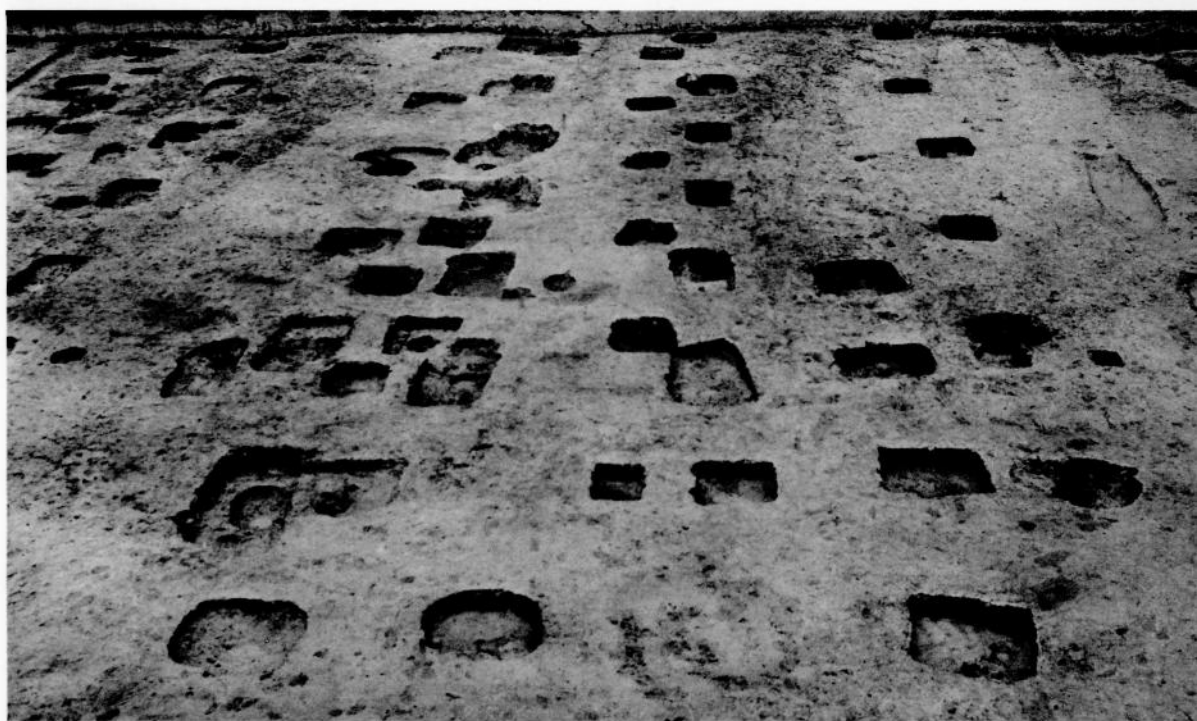
2. SB6171・6172  
重複状況 南から

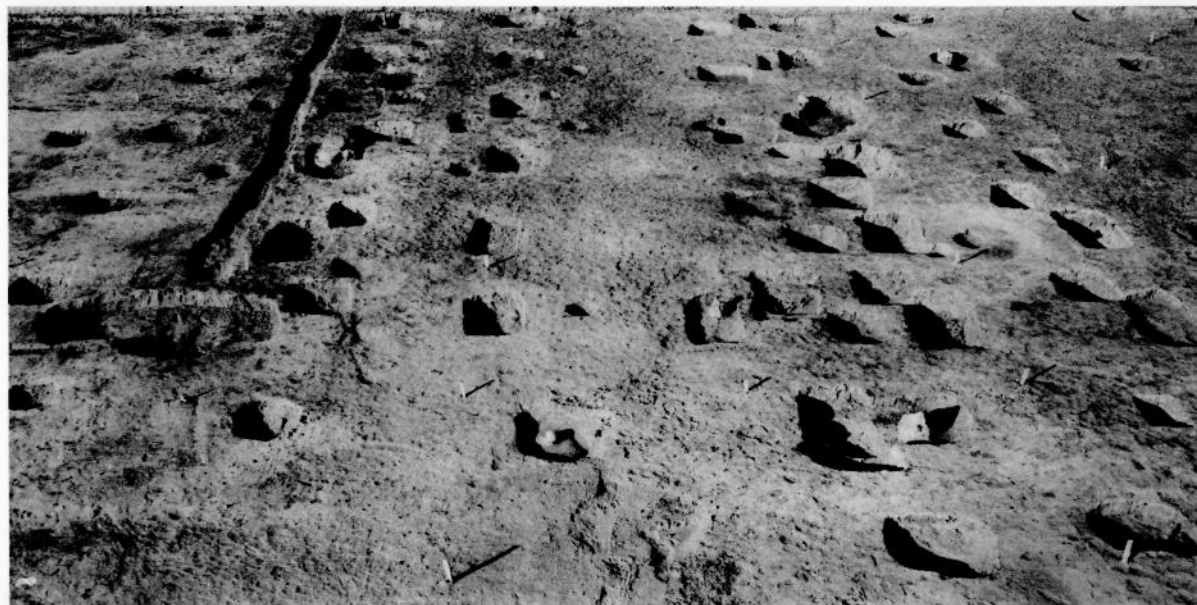
3. SB6173・6175  
重複状況 南から

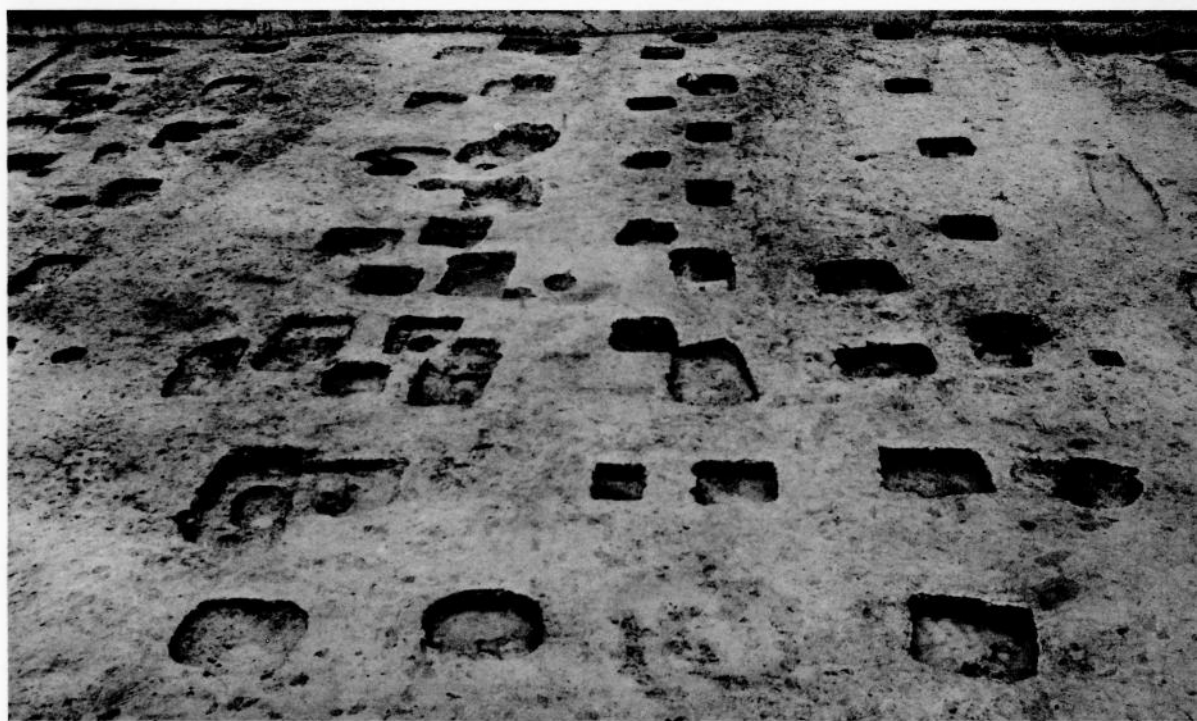
2. SB6171・6172  
重複状況 南から

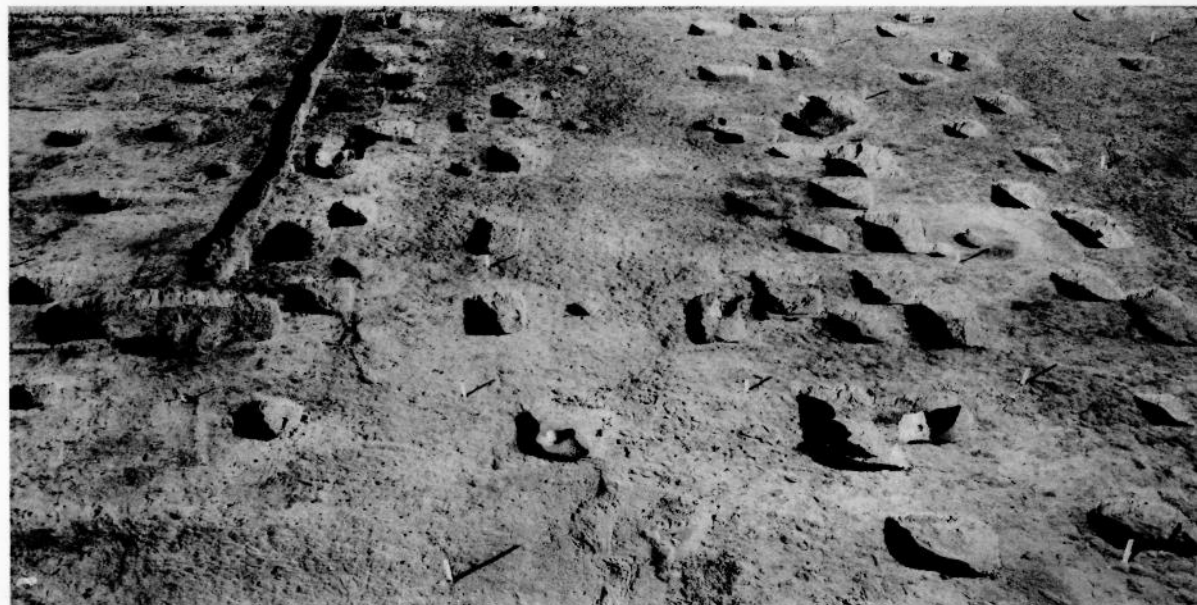
3. SB6173・6175  
重複状況 南から

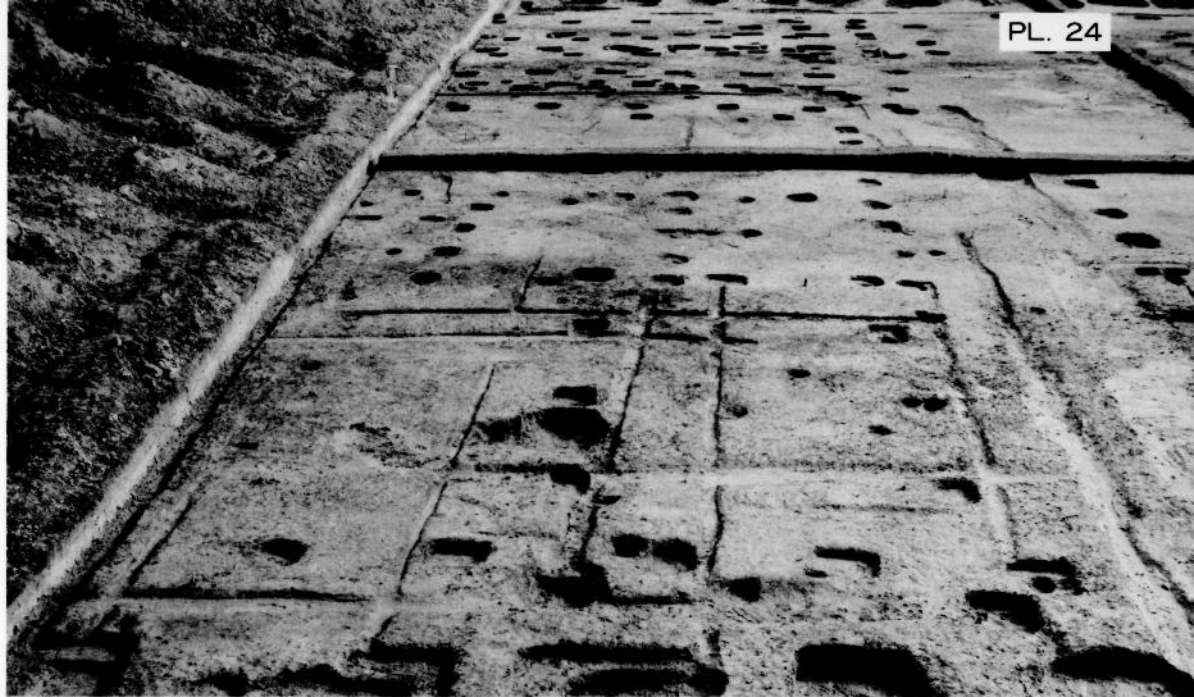
1. SB6187・6188・  
6191 重複状況  
西から

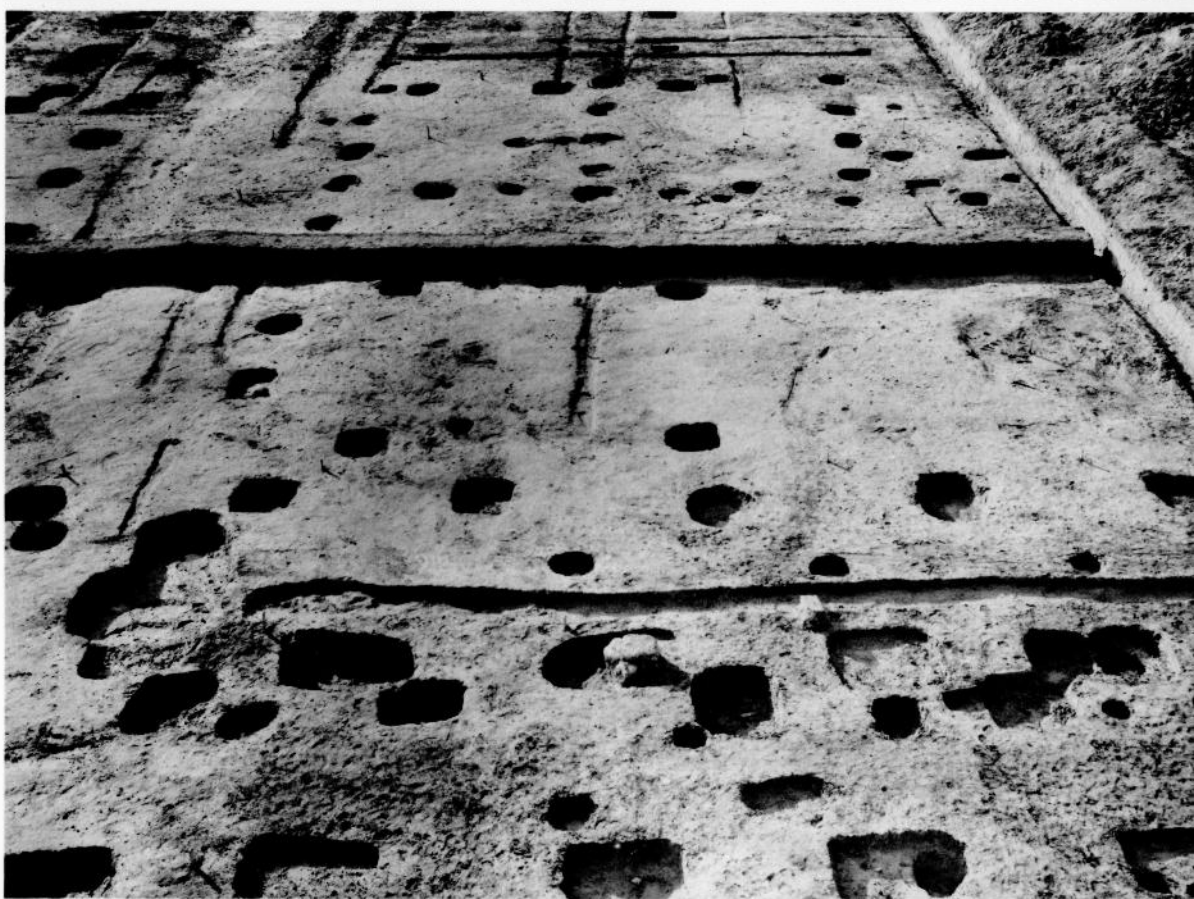
2. 同上 東から

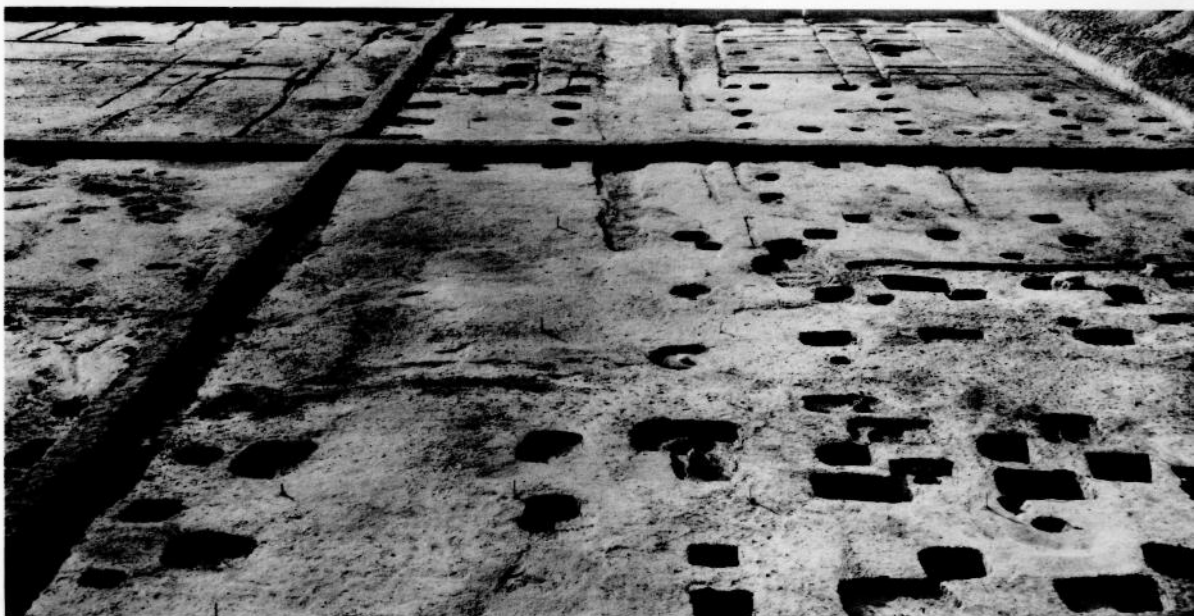
3. SD6181とその  
南北の建物群  
東から

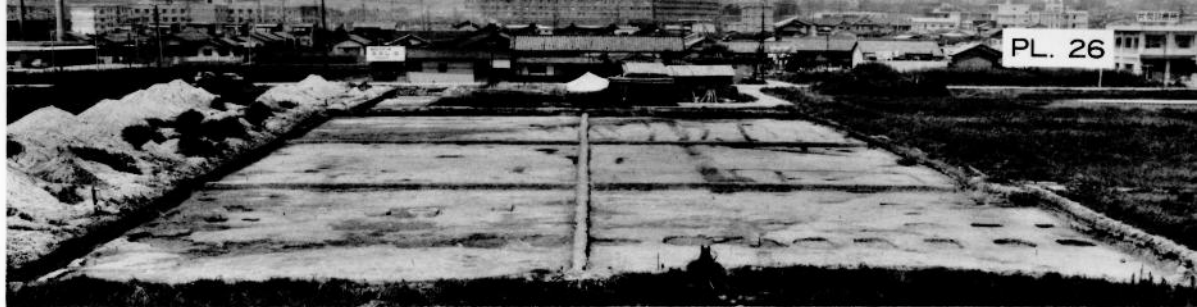
2. 南北塀SA5950と  
馬寮東官衙西限溝  
SD5960 北から

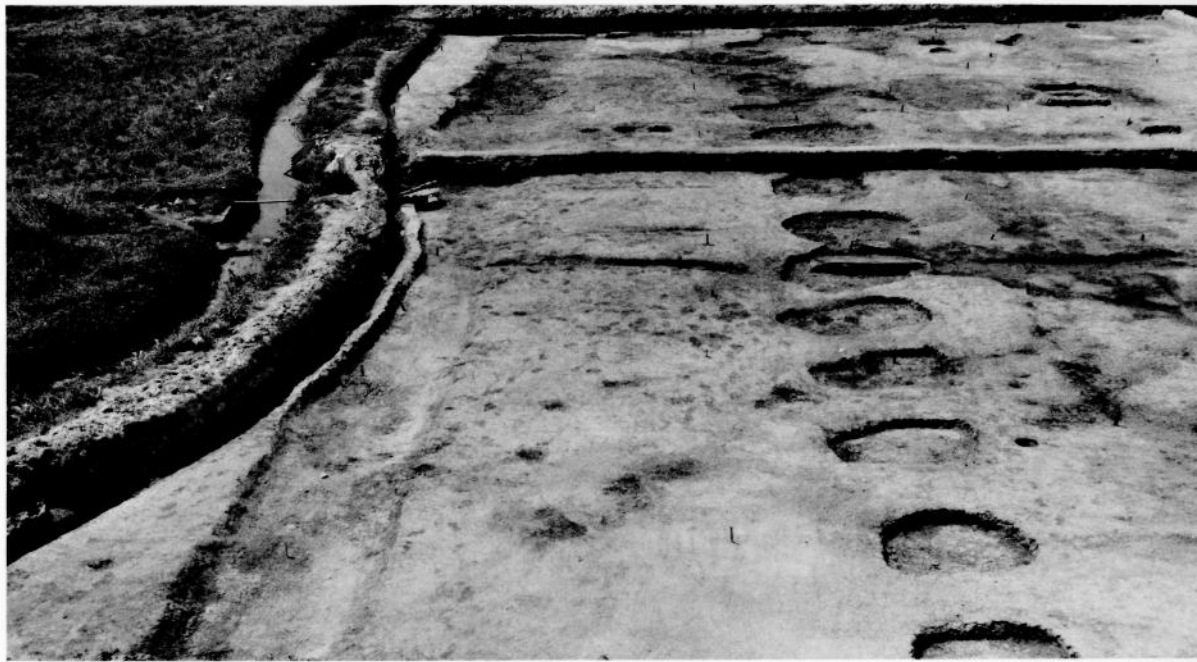
3. SB5952・5953等  
宮廃絶後の小規模建物群  
北から

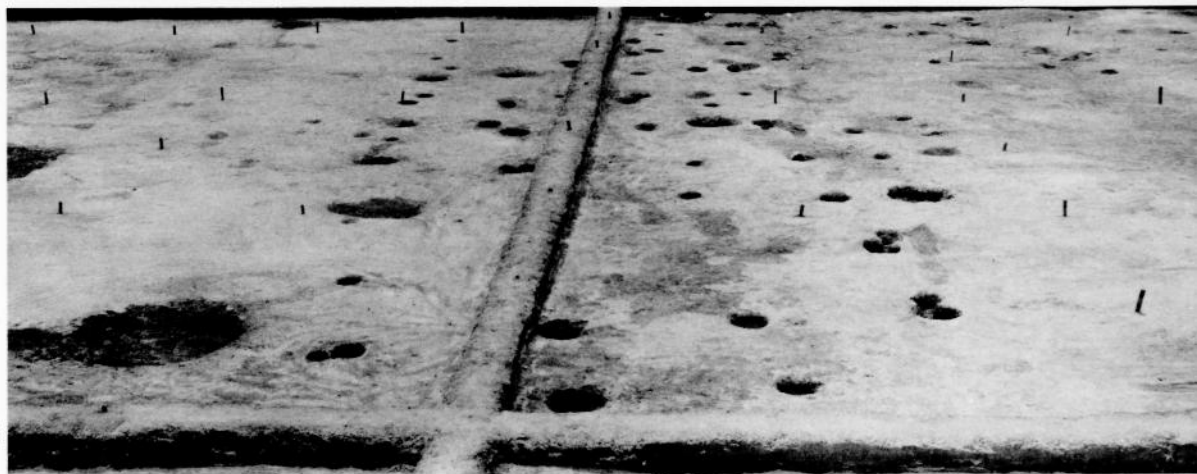
4. SB5941 北側柱列  
東から

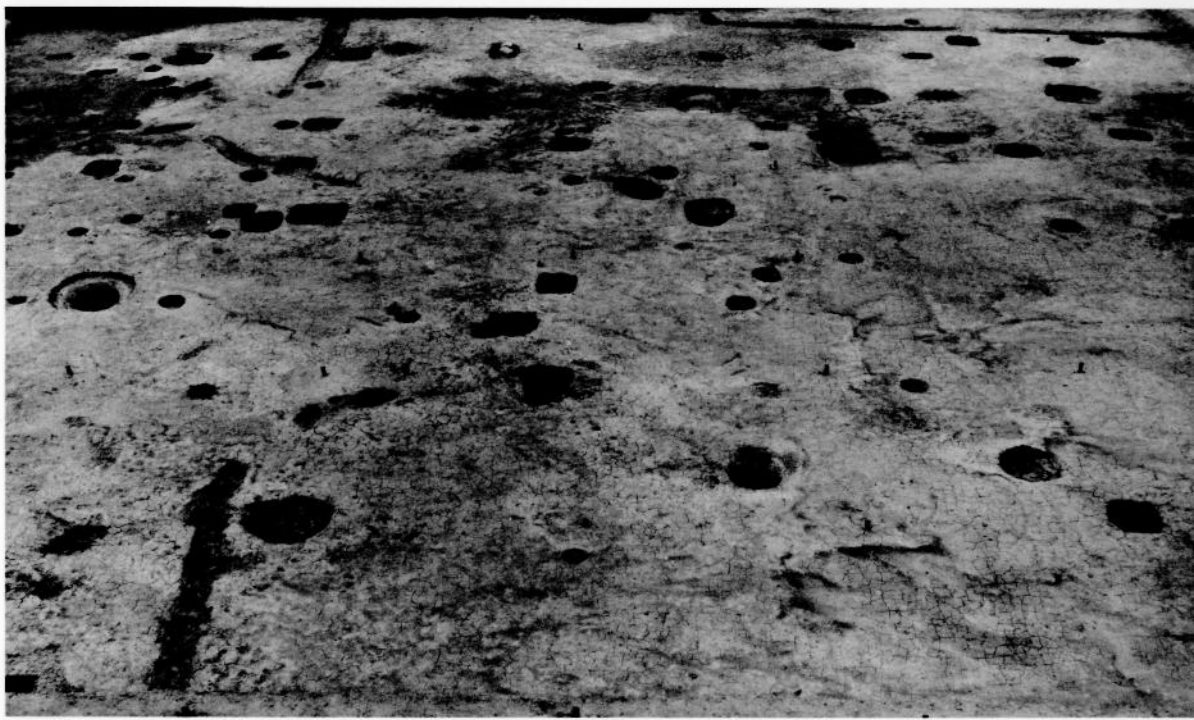
2. SB6075・6080等  
宮廃絶後の小規模建物群  
北から

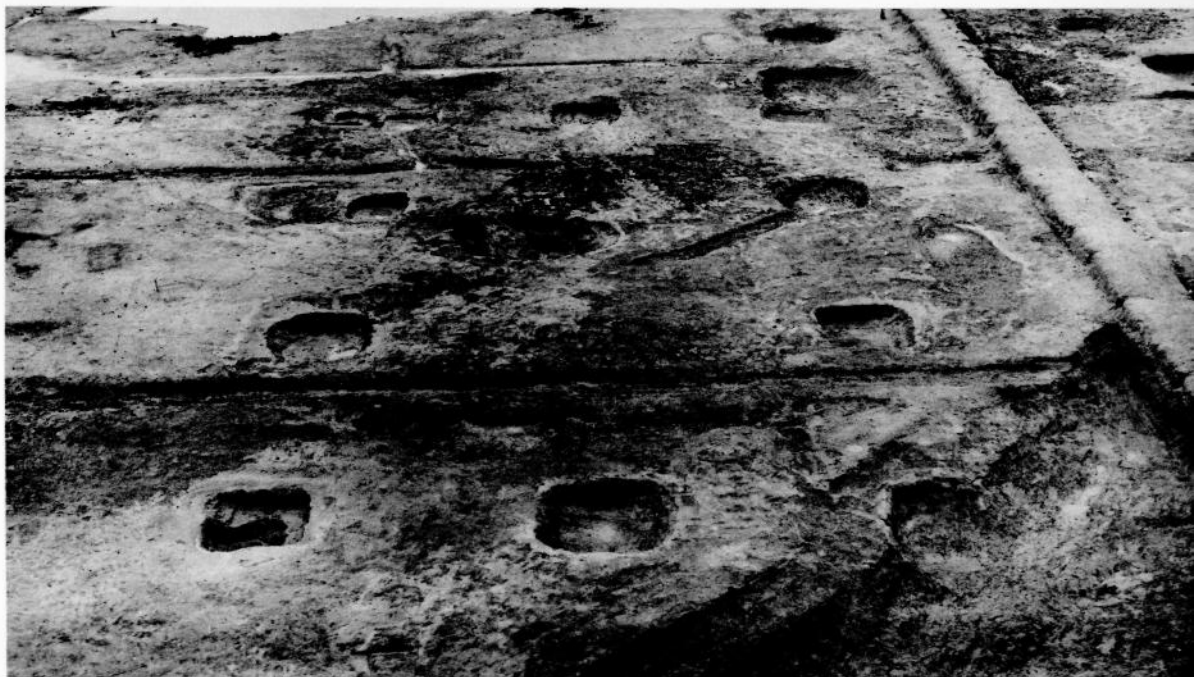
3. SB6095 西から

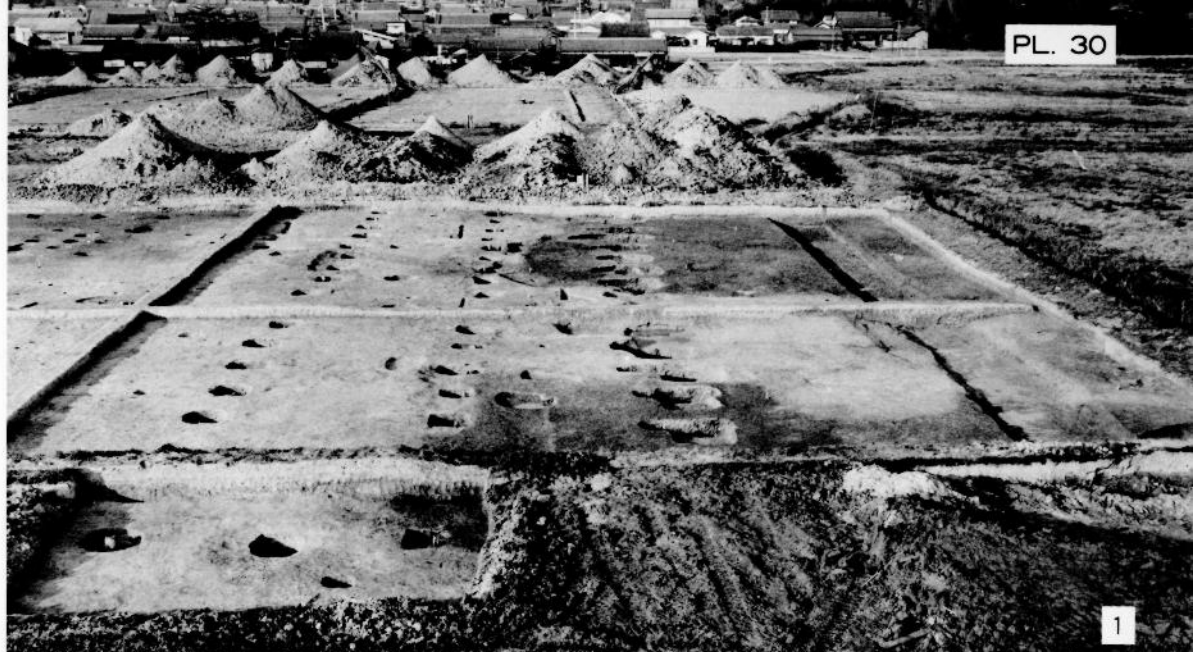
1

1. 第I期馬房SB5955・  
5956と南北塀  
SA5950 南から

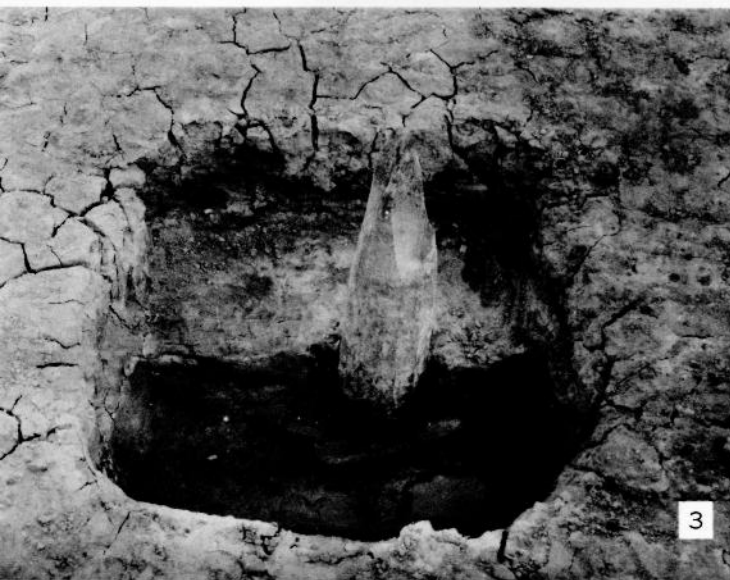
3

2. 同上 細部 南から  
3. SB5955の柱根 南から  
4. 同上 南から

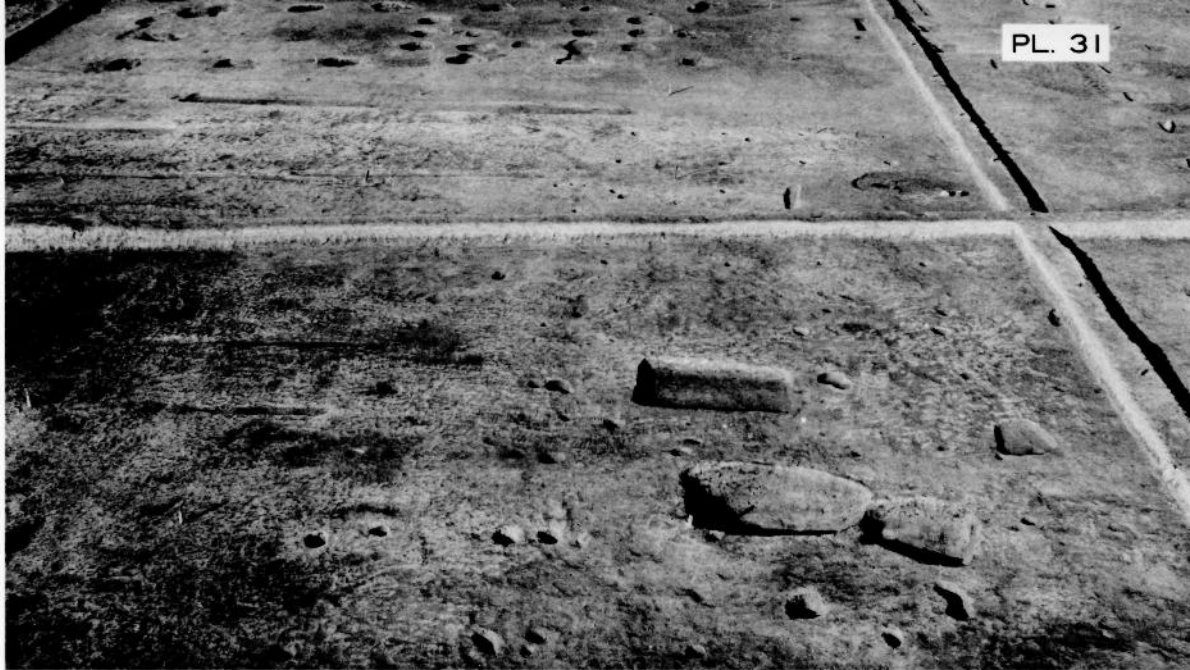
2. 第V期南半部正殿風  
建物SB6130 南から

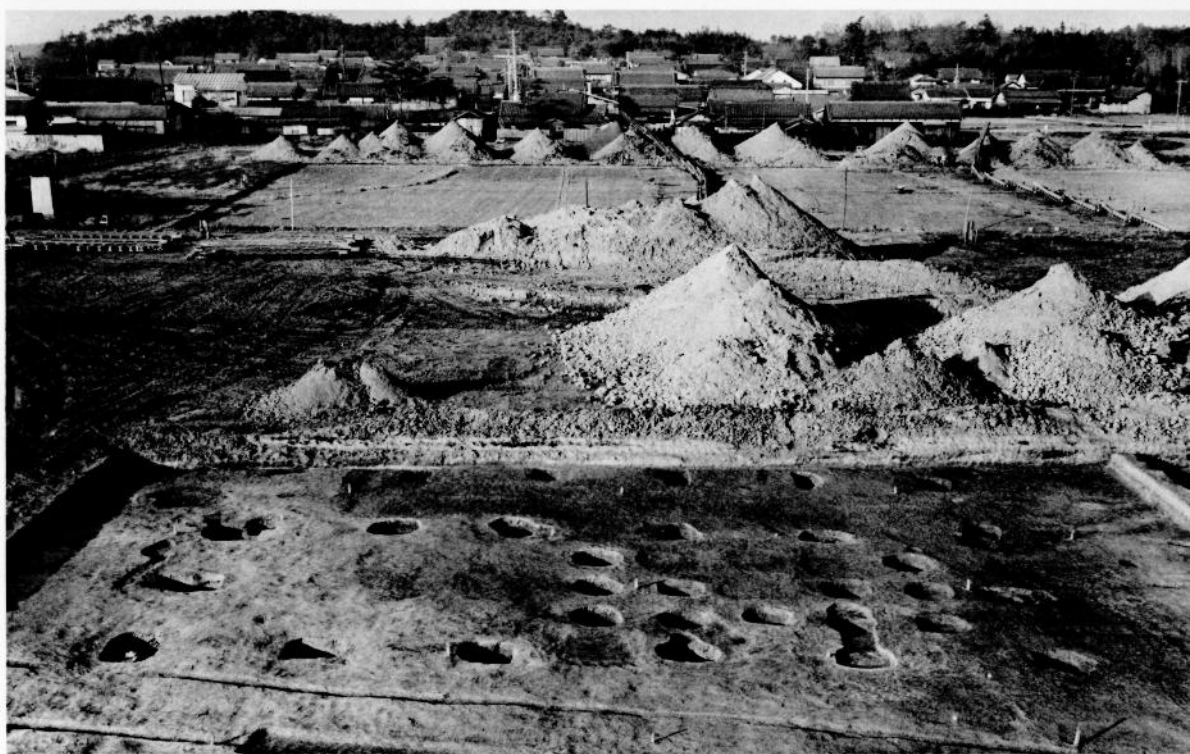
3. 同上 西から

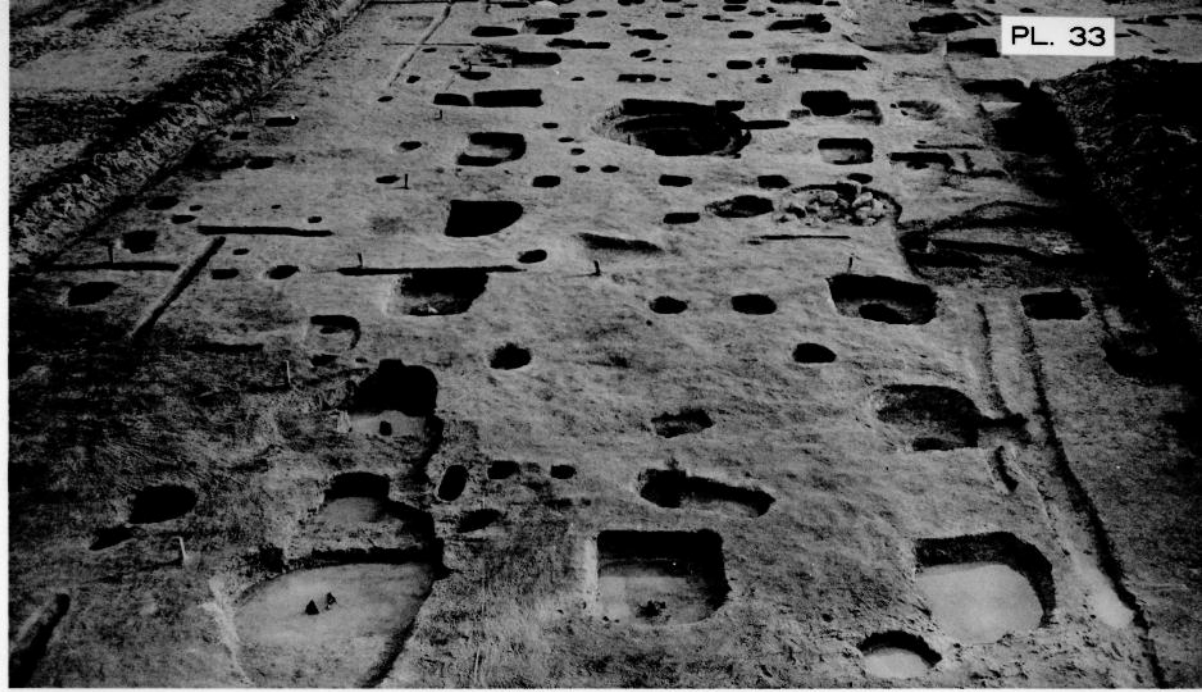
1. 第Ⅳ期馬房 SB3690  
北半部 北から

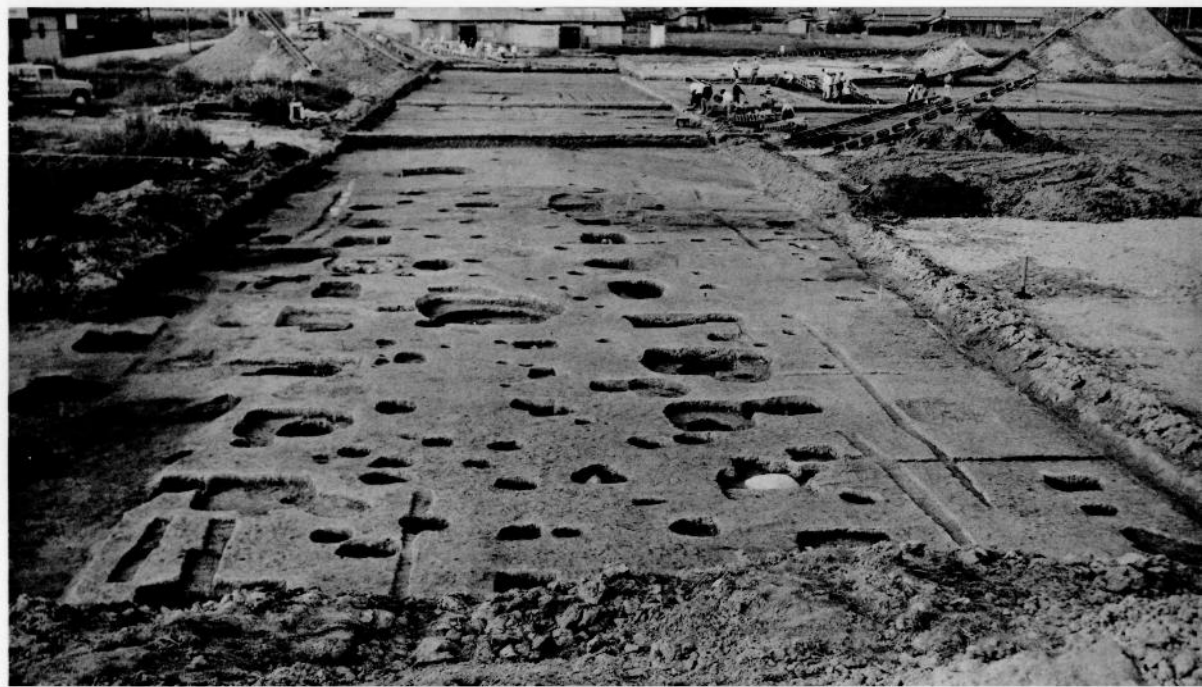
2. 同上 南から

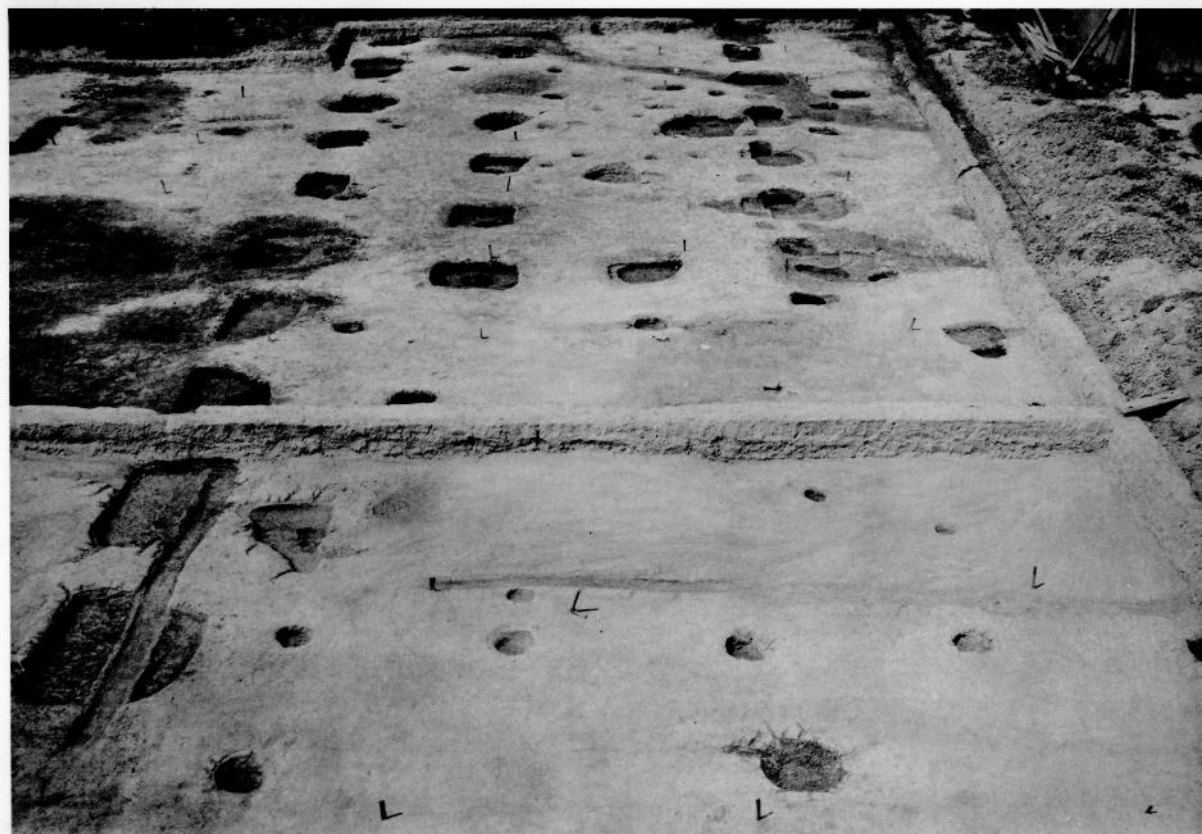
3. SB3690 南半部  
南から

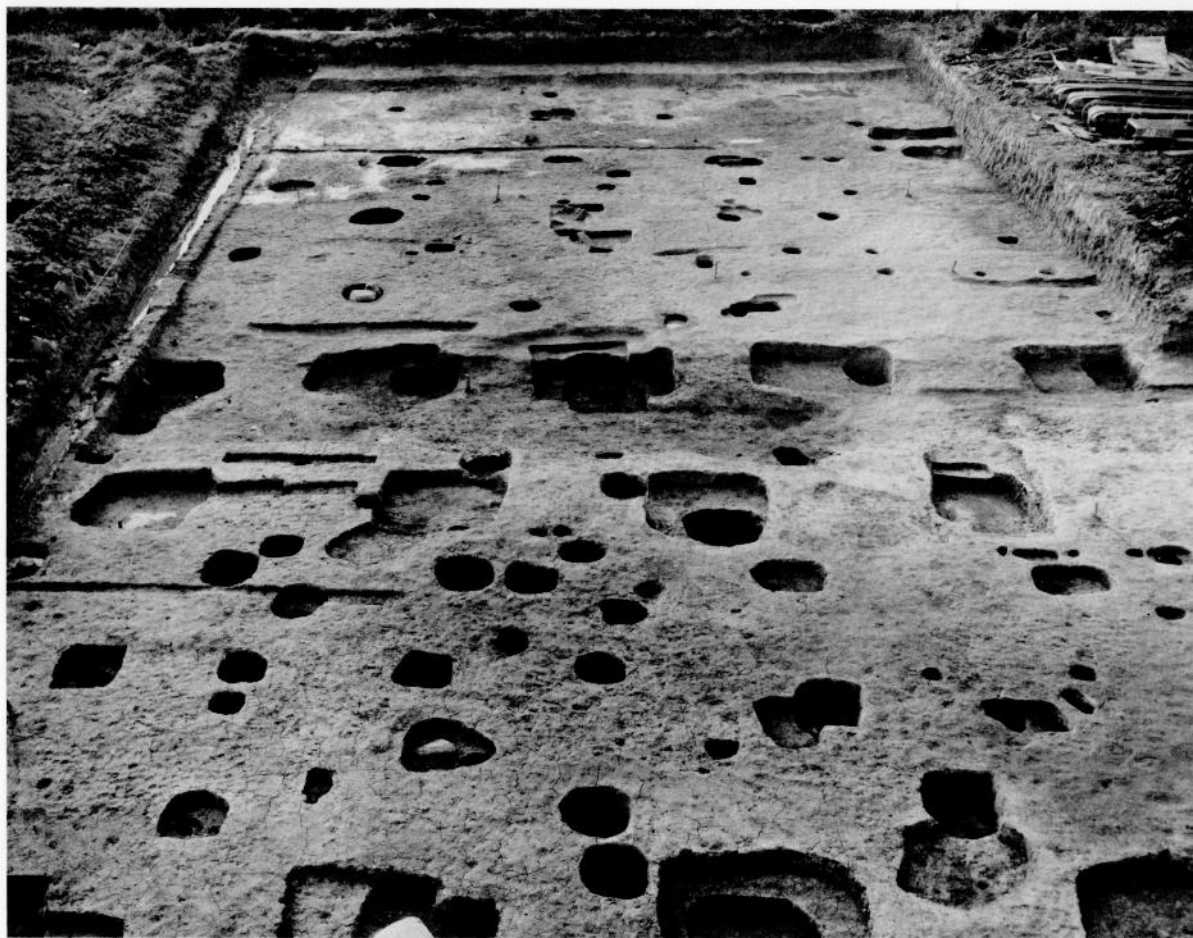
2. 南北塀SA3680とその  
東西にある小建物群  
SB6101・6102  
東から

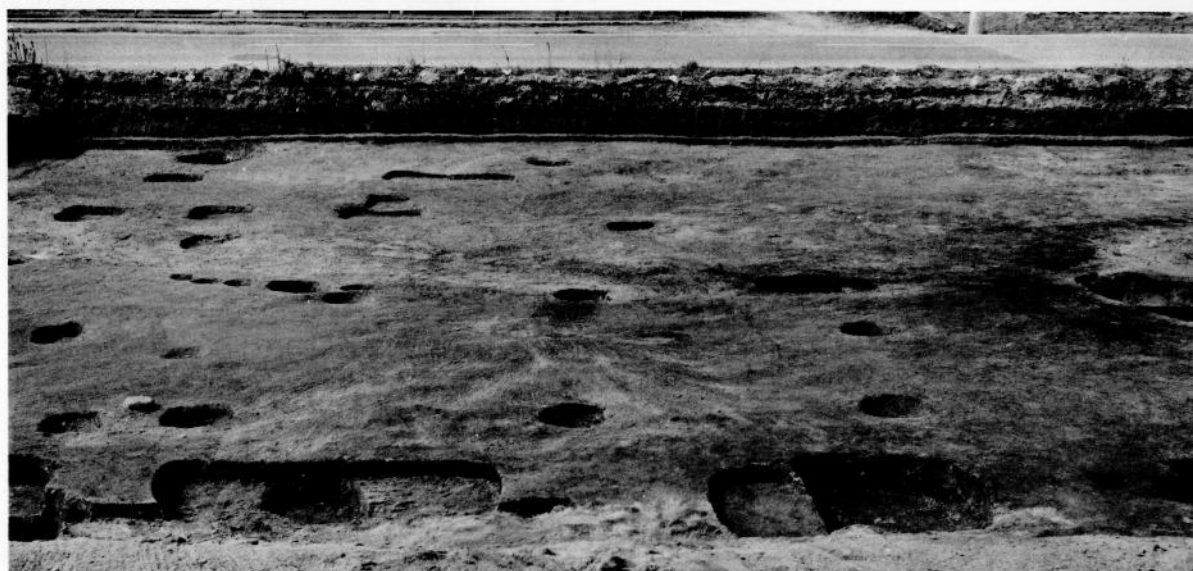
3. 南北塀SA3680と  
建物SB6302 東から

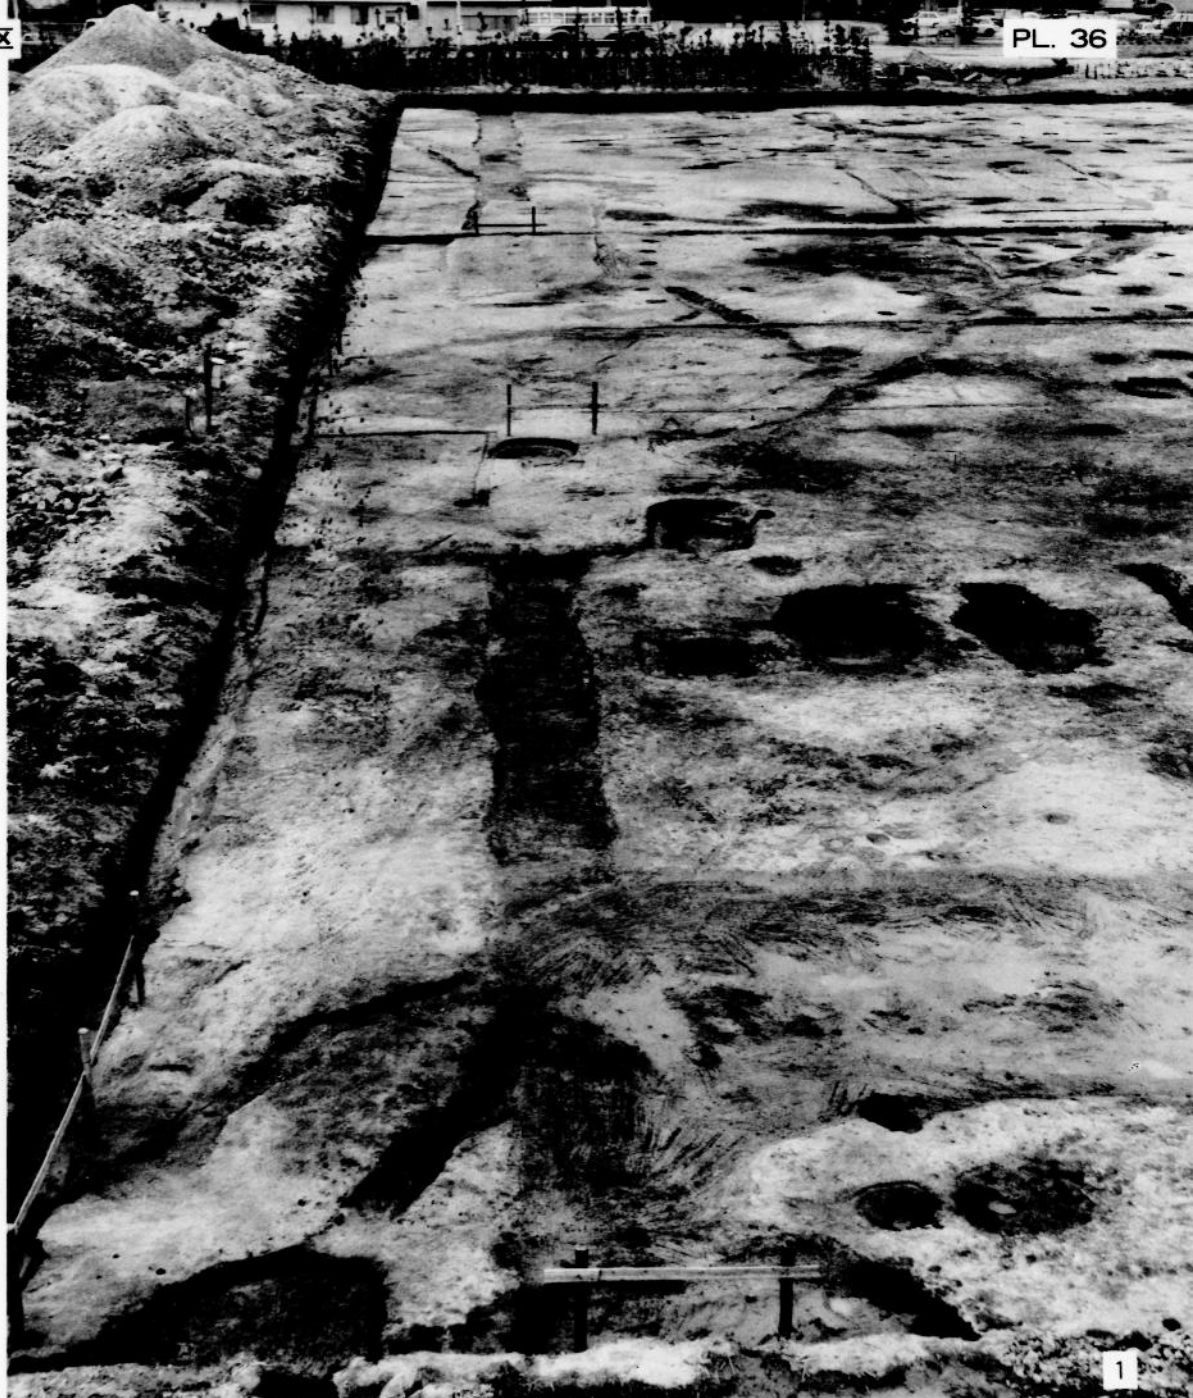
1

- 1. 第I期地割溝SD6980  
全景 東から
- 2. 同上 西半部 東から
- 3. 馬寮東官西衙限溝  
SD5960南端屈曲点  
(断割後) 東から

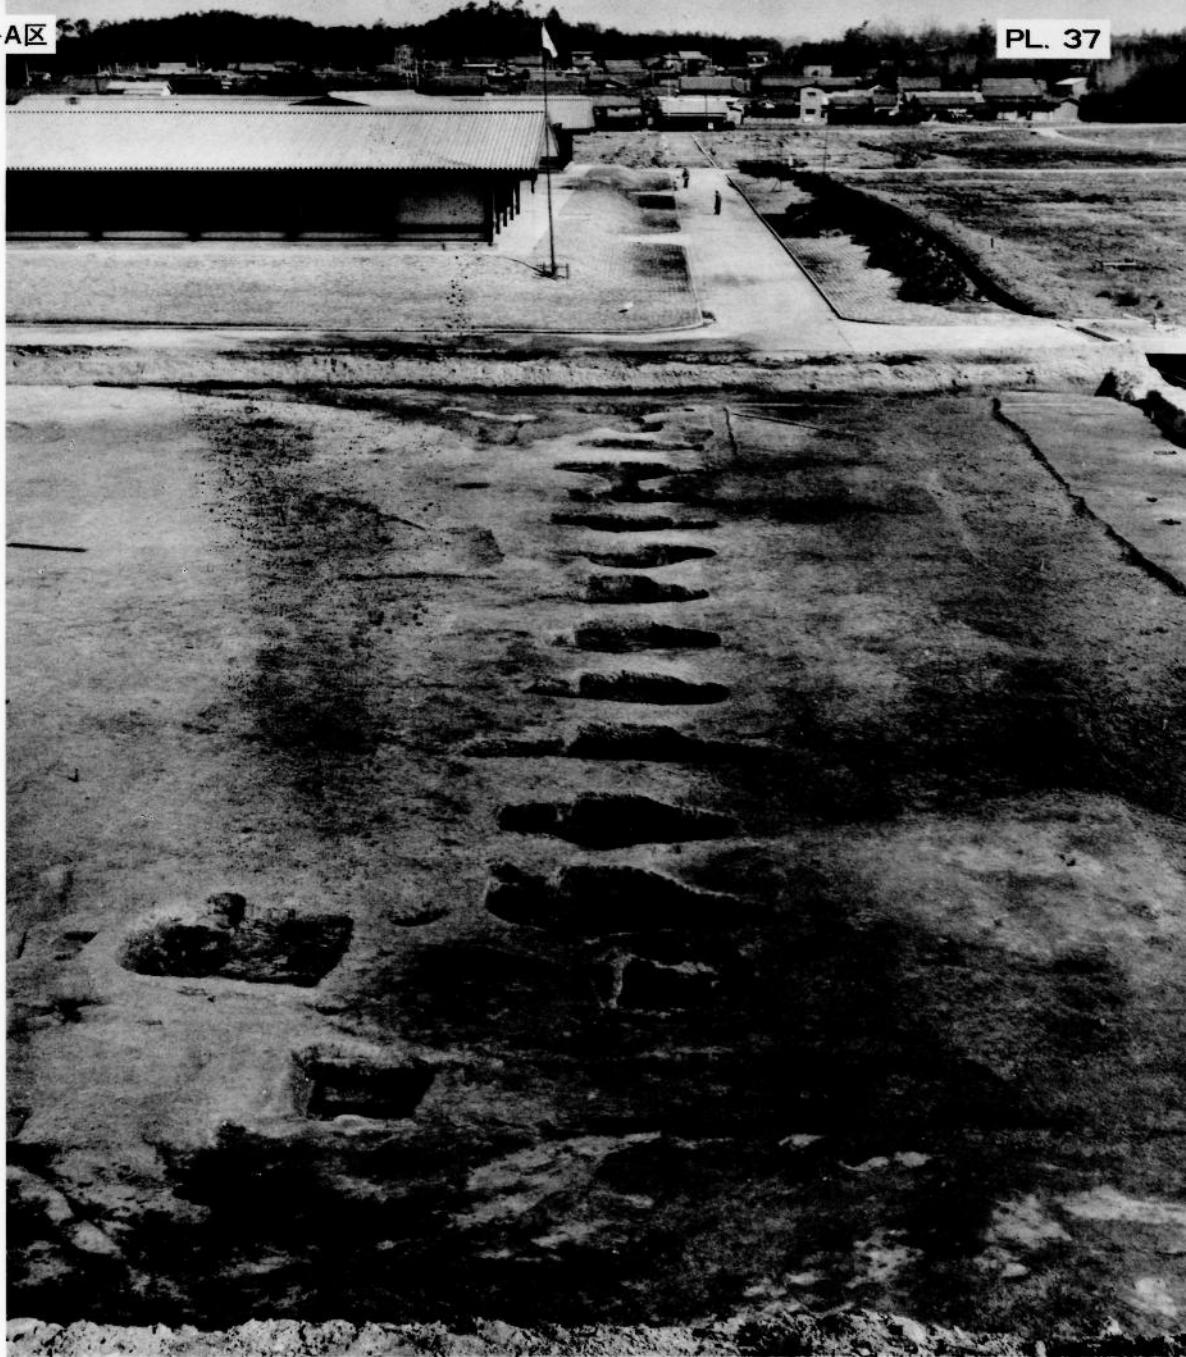
1. 南北塀SA5950南端部  
南から
