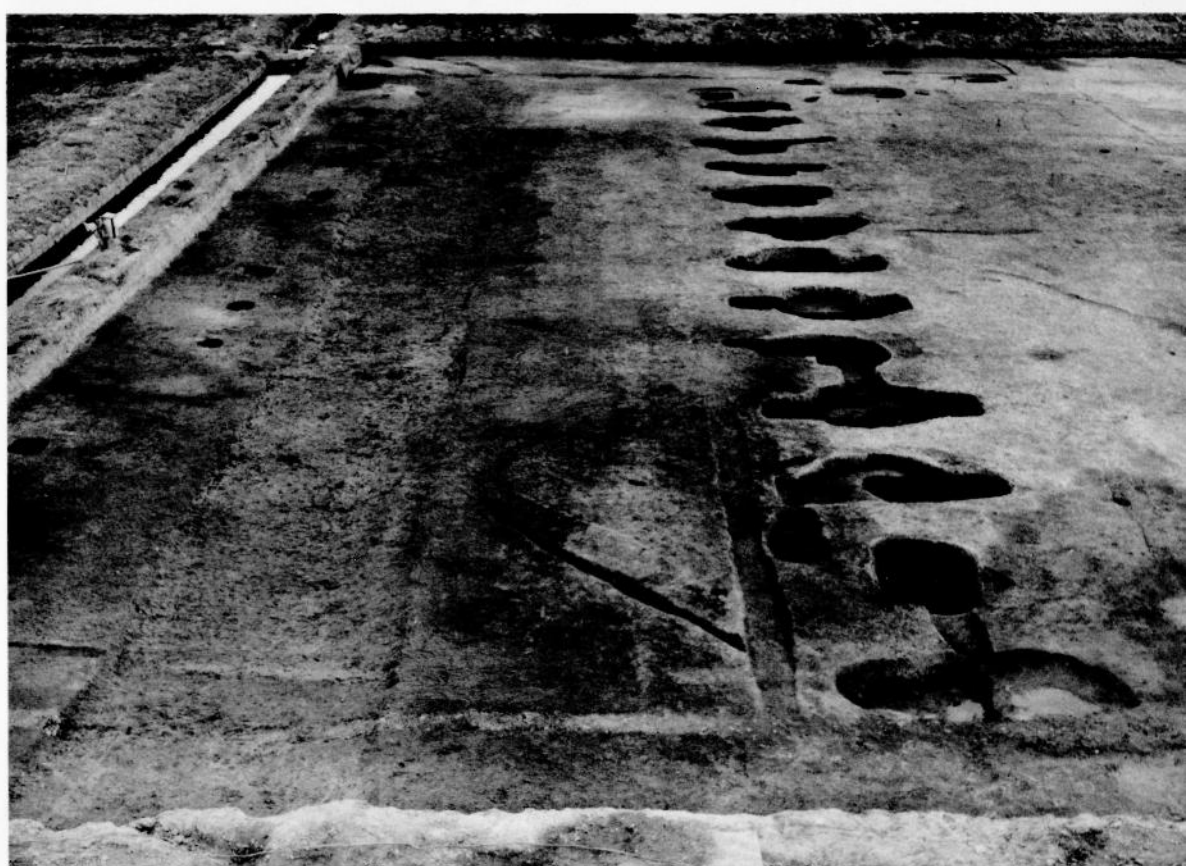
2. 同上 北から

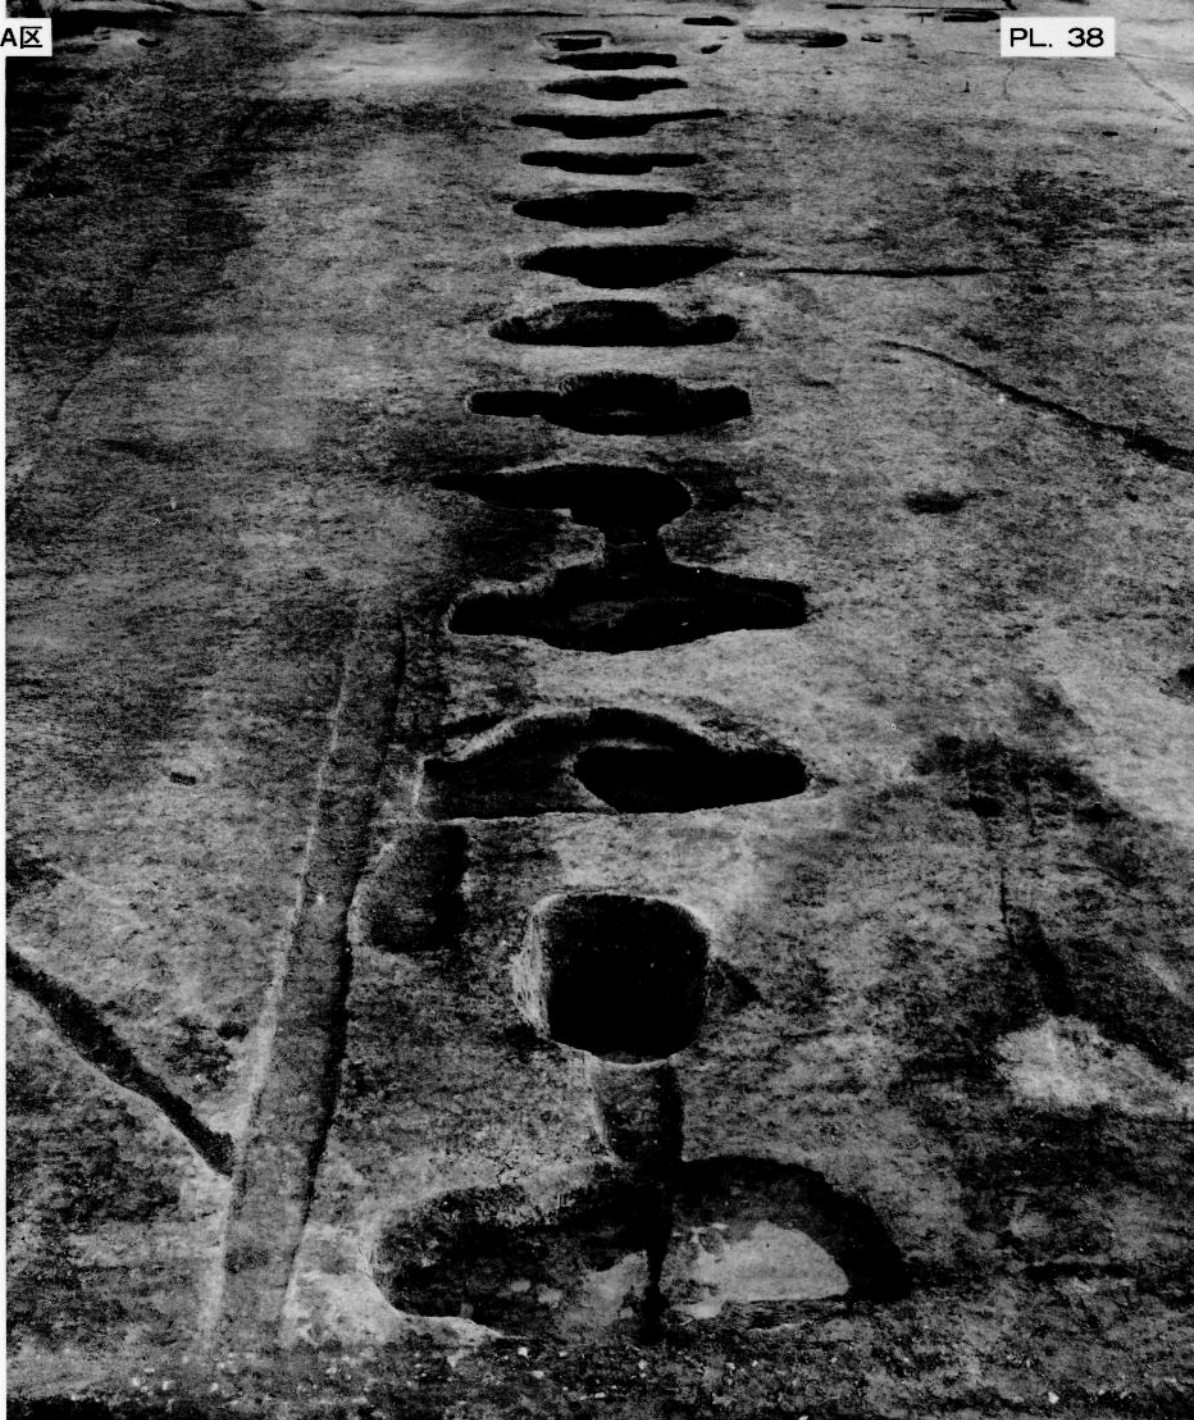
1. 南北塀SA5950南端部  
北から

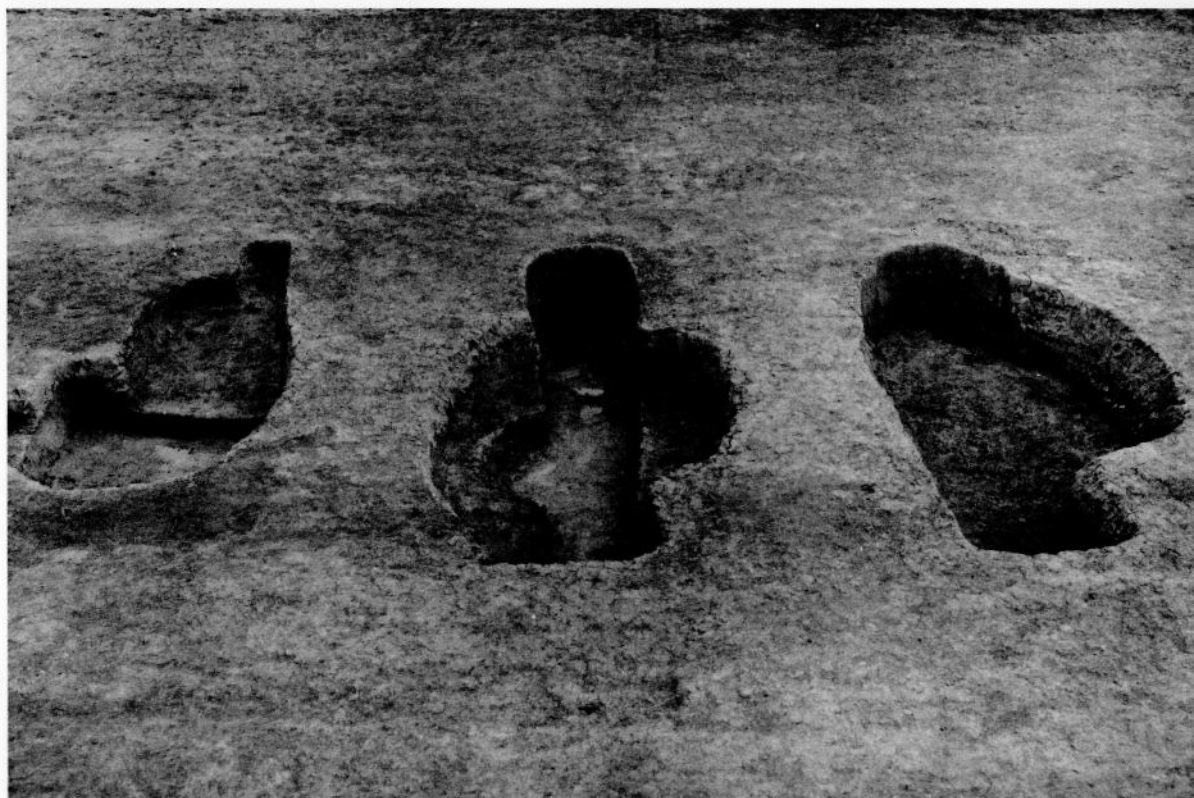
2. 同上 南から七・八間目  
細部 西から

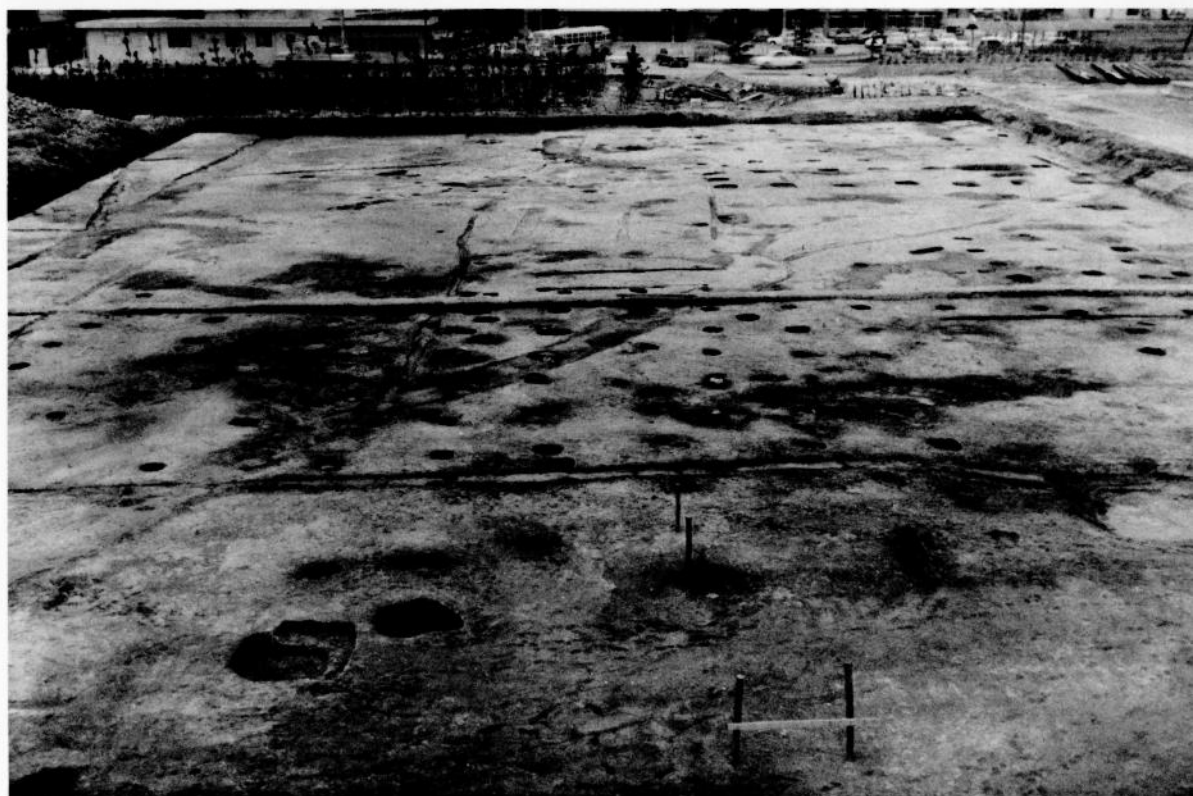
2. 宮廃絶後小規模建物群  
SB7024・7030等  
東から

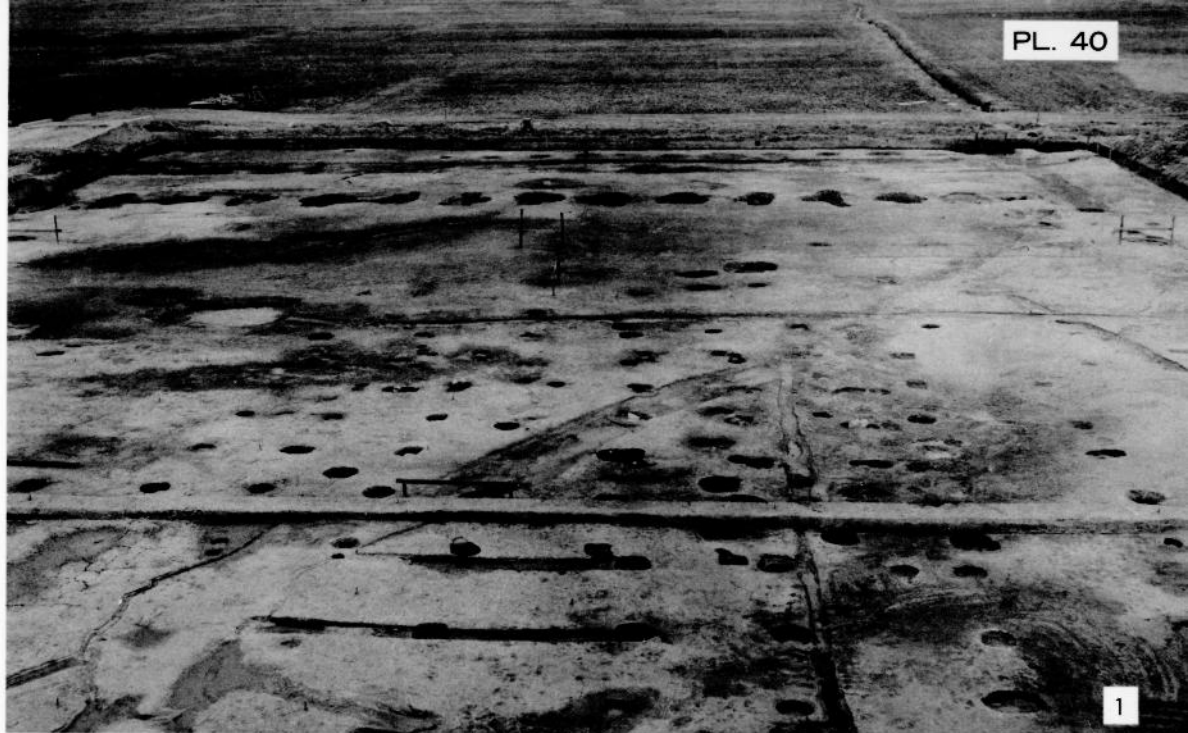
1. 宮廃絶後小規模建物群  
SB7024・7026・  
7030等 西から
