## 西トップ遺跡南祠堂の解体による新発見 New Discovery in the Wake of Dismantlement of the Southern Sanctuary, Western Prasat Top

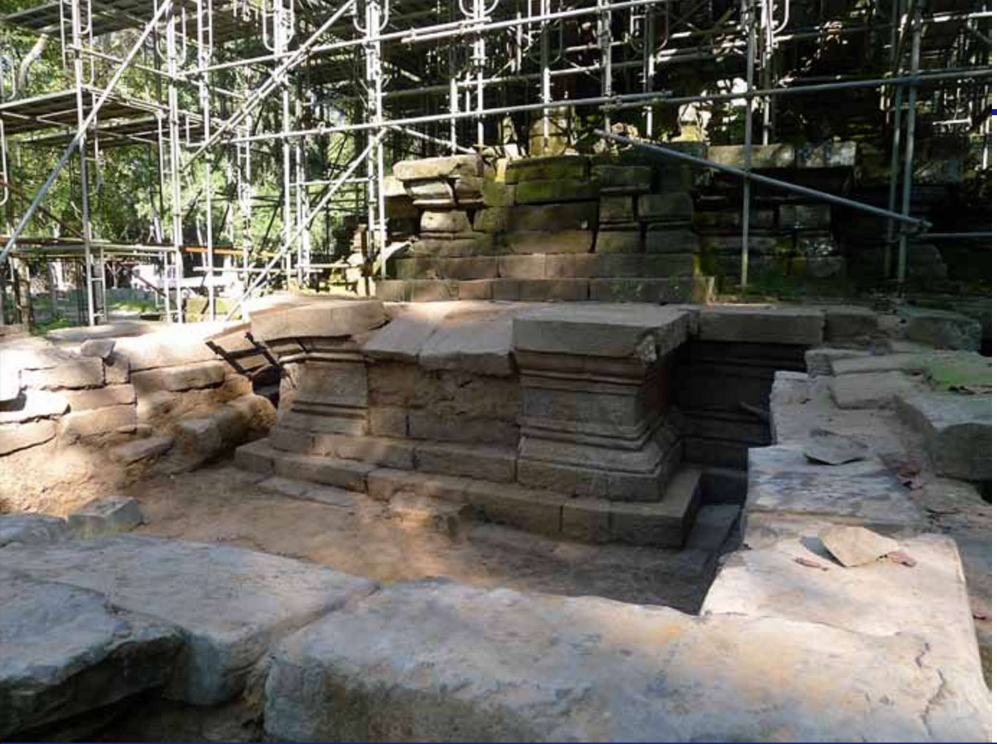
上：南祠堂の下成基壇の解体によって明らかになった中央祠堂の南面階段（南から望む）

Above: Southern stairs of the Central Sanctuary has been revealed after the dismantlement of the lower foundation of the Southern Sanctuary (a view from the south)

西トップ遺跡の解体修理は南祠堂から始まりました。そして南祠堂の下成基壇（下から一段目の基壇）を解体していると、そこで注目すべき発見がありました。となりあう中央祠堂の南面階段の下部が姿を見せたのです。この階段は、南祠堂の下成基壇にちょうど埋め殺された状況になっていたことが判明したのです。

The restoration of Western Prasat Top was started from the Southern Sanctuary. A notable fact has been revealed during the dismantlement of the lower (the first-tier) foundation of the Southern Sanctuary. The lower part of the southern stairs of the Central Sanctuary has been uncovered inside the foundation. It is revealed that the stairs had been embedded inside the foundation of the Southern Sanctuary.

This discovery has an implication for understanding the order of the constructions at Western Prasat Top. Our architectural research has indicated the possibility that the Northern Sanctuary was added onto the Central Sanctuary made by sand stones. Regarding the Southern Sanctuary, however, there still have been possibilities whether it was built after the Central Sanctuary, or it was constructed at the same time of the Central Sanctuary construction. This new discovery suggests that the Central Sanctuary made by sand stones stood alone first, then the Southern Sanctuary was built in contact with the south side of the Central Sanctuary, and at that time the lower part of the southern stairs of the Central Sanctuary was embedded inside the lower foundation of the Southern Sanctuary.

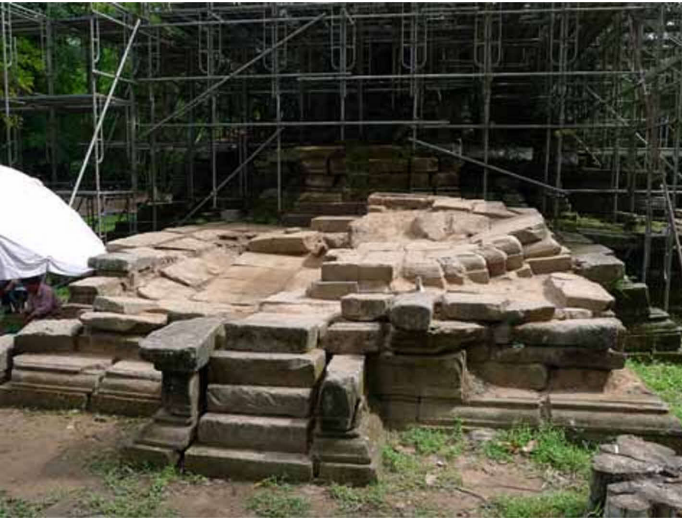
左：下成基壇を解体する前の南祠堂の状況。建物部分（上部構造）および上成基壇の一部はすでに解体されている。この下成基壇の内部の敷石と盛土を取り払うと、埋め殺されていた中央祠堂の南面階段の下部が姿を見せた（南から望む）

Left: Situation before the dismantlement of the lower foundation of the Southern Sanctuary. The building (upper structure) and a part of the upper foundation have already been removed. The lower part of the southern stairs of the Central Sanctuary, that had been buried inside the lower foundation of the Southern Sanctuary, was appeared after removing the floor stones and the filling of this foundation (a view from the south)

この発見により、西トップ遺跡における建物の構築順序をより明確に理解できるようになりました。すでに建築学的な検討から、北祠堂は砂岩製の中央祠堂の建築時期よりも後に増築された可能性が高いことが指摘されていましたが、南祠堂については、砂岩製の中央祠堂より後に増築されたのか、それとも最初から一体のものとして建築されたのか、はっきりとした決め手はありませんでした。しかし今回の発見により、まず砂岩製の中央祠堂が単体として建てられ、その後、それに擦り付けるようにして南祠堂が増築され、そのとき中央祠堂の南面階段の下部が南祠堂の下成基壇の内部に埋め込まれてしまったという状況が明らかになったのです。

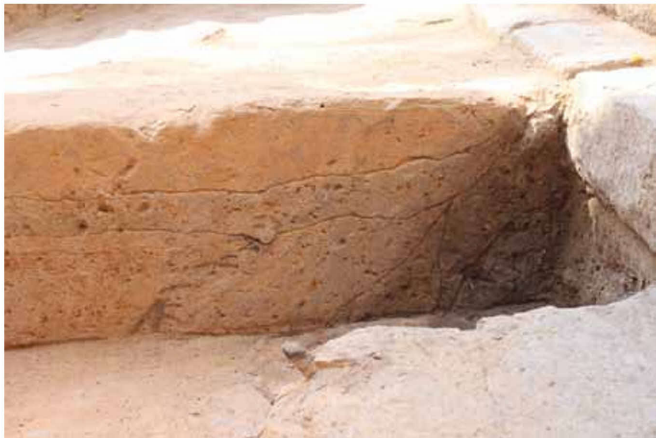
南祠堂の下成基壇の断面の様子。基壇の内部はサラサラの砂によって充填されていた。  
Profile of the inside of the lower foundation of the Southern Sanctuary. The interior of the foundation is filled by loose sand.

さらに、南祠堂の下成基壇の内部を充填していたのはサラサラの砂であったことも、解体によって明らかになりました。南祠堂の建物が大きく傾いていた原因は、この下成基壇内部の砂が脆弱だったことによる可能性が高いと考えられます。

The examination during the dismantlement of the Southern sanctuary also reveals that the filling inside its lower foundation is made by loose sand. We suspect that the weakness of the fillings of the foundation is a significant cause of uneven settling and inclining of the upper structure of the Southern Sanctuary.
