西トップ遺跡南祠堂の解体 Dismantlement of the Southern Sanctuary, Western Prasat Top

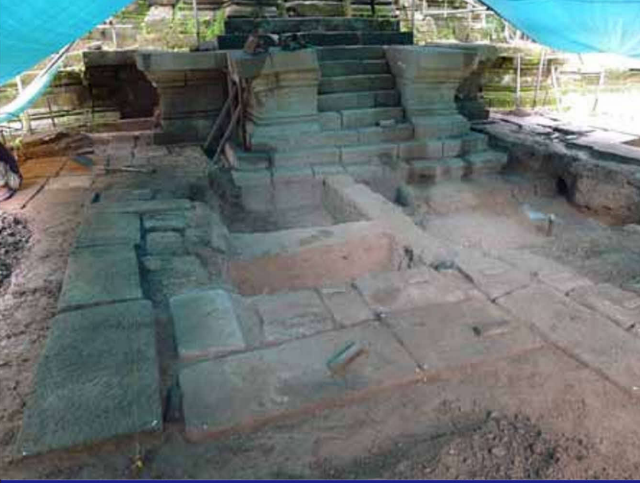
最下部の一段の石材を残して解体が完了した南祠堂

Dismantled Southern Sanctuary beside the lowest stones

2012年3月から開始した西トップ遺跡南祠堂の解体は、ついに最下段の石材を残して他のすべての石材の解体が終了しました。そして解体と同時並行でおこなわれた考古学的発掘により、南祠堂の詳細が明らかになりました。

The dismantlement for repairing of the Southern Sanctuary, started in March 2012, has been completed except the series of the lowest stones of the platform. An archaeological excavation associated with the dismantlement revealed the detail information of the construction of the Southern Sanctuary.

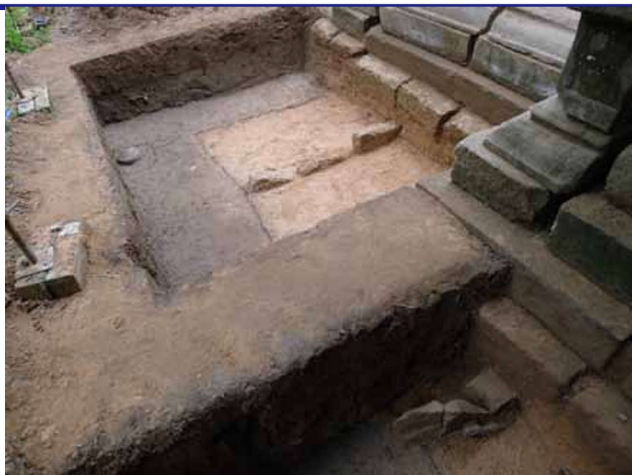
南祠堂南側の N トレンチの様子（南東から）：明褐色に見える部分が「掘込地業」の内部に詰められた砂

N trench in the south of the Southern Sanctuary (from the southeast): the light-brown soils are the fillings of the foundation

2012年6月に南祠堂の西側（Mトレンチ）で試掘をおこなったとき、南祠堂にともなう基礎の痕跡は確認されませんでした。しかし2013年6月に南祠堂の南側（Nトレンチ）で試掘調査をおこなったところ、いったん地面を掘りくぼめ、内部を砂で埋め戻す「掘込地業」と呼ばれる基礎の痕跡がみつかりました。この「掘込地業」は他のアンコール遺跡の寺院のいくつかでも確認されていますが、西トップ寺院での存在が確認されたのは今回が初めてです。

「掘込地業」の内部の砂は、基壇の中の砂とほぼ同じものでした。すなわち南祠堂の内部にはこのような砂が詰まっていたことがわかりました。一見すると構造材として砂は脆弱なように思われるのですが、なぜ砂が選ばれたのかという理由はまだ明らかになっていません。

We carried out excavation in the western side of the Southern Sanctuary in June 2012 (Trench M); however, no evidence of foundation associated with the Southern Sanctuary was found. In June 2013 we opened a trench in the southern side of the Southern Sanctuary (Trench N), then we revealed an evidence of foundation. The foundation was made in the way hereinafter described; first, a pit was dug, and then, the pit was filled by fine sand. Existence of this kind of foundation is widely recognized at the sites of Angkor area; however, this is the first time to be recognized at Western Prasat Top.

The sand filling inside the foundation is the same as the filling of the platform. Therefore the sand is used as a construction material of the Southern Sanctuary. It seems that sand is weak and not suitable for construction material. The reason why sand was used for construction has not been cleared yet.

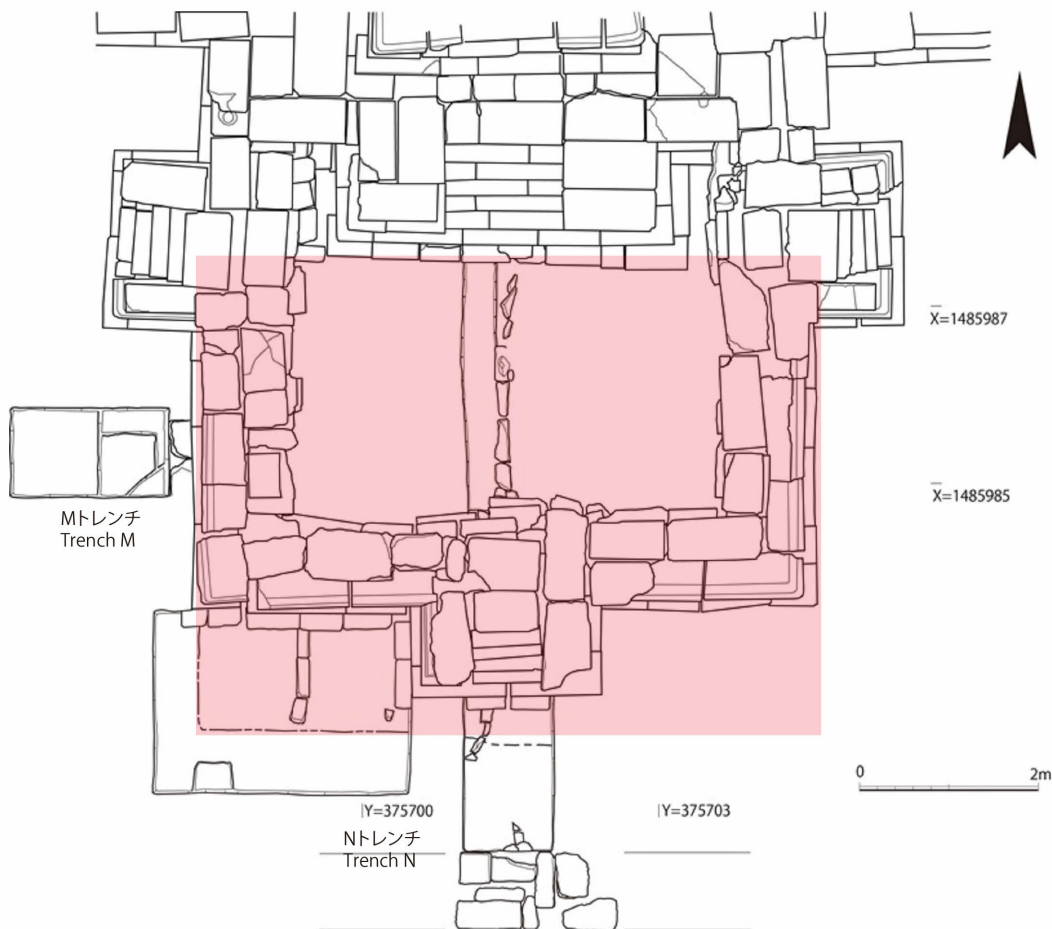
南祠堂の平面図と想定される「掘込地業」の範囲（ピンク色で示した部分）

Plan of the Southern Sanctuary and the estimated extent of the foundation (indicated by pink)

右の図で示したのが想定される南祠堂の「掘込地業」の範囲です。西側では基壇の内側にあるため、Mトレンチの調査では確認できなかったものと考えられます。

The figure (right) indicates the estimated extent of the foundation. Since the foundation is positioned inside of the western outline of the platform, it has not been recognized by the excavation of Trench M.
