南祠堂の再構築に向けて

Toward Reassembling of the Southern Sanctuary, Western Prasat Top

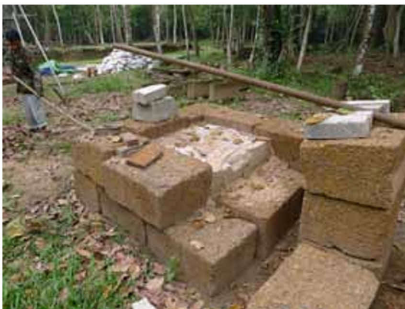
南祠堂の基壇・掘込地業に充填するための土壌の強度試験用のテスト・ユニット
Test-unit for strength of consolidated soil for the platform and foundation of the Southern Sanctuary

To cease the process of collapsing, we adopt the method to substitute a consolidated soil for the original sand inside the platform. The consolidated soil is a pounded earth of a mixture of sand, lime powder, laterite powder and clay in the appropriate ratio. The original sand is to be reused for the consolidated soil. Our strength test conducted at test units verified that the soil is strong enough to sustain the structure.

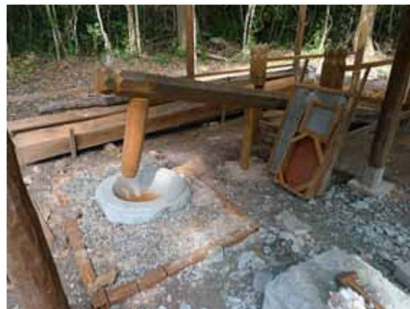
強化土壌に混ぜるためのラテライト粉末を作るための臼と杵
Mortar and pestle to make laterite powder for the consolidated soil
