## トピックス 国宝高松塚古墳 保存修理のための石室解体

## Topics: The dismantlement of Takamatsuzuka stone chamber to preserve mural paintings.

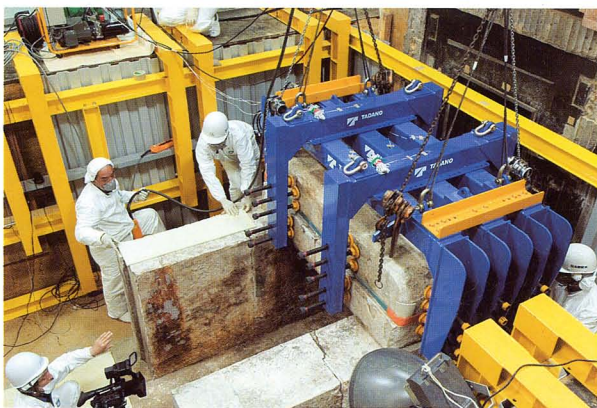
最も危険な天井石1（南側）は、ⅡⅢ型治具と補助治具を用いて、四方から石材を拘束して、地切り・移動した。

The most fragile ceiling stone (no. 1, the southernmost), is separated from its setting and moved with specially designed jig, after holding the stone and lift up.

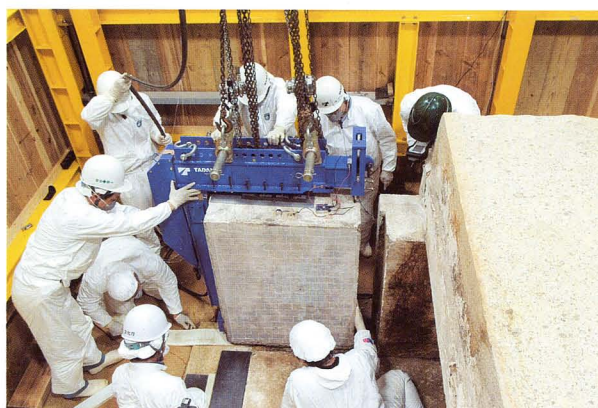
東壁石3（女子群像）は、床石と壁石の間と上部の相欠き部の隙間に先端刃を挿入して「Γ」型治具を取り付けて、地切りと移動をおこなった。

Stone no. 3 of the eastern wall (bearing images of a group of women) is separated from its setting and moved, after inserting the tips of the blade with "Γ"-shaped jig in the interstices with the floor stone and in the upper halving joint.
