## トピックス 「高松塚古墳と南海地震」

## Topics: Takamatsuzuka Tomb and the Nankai Earthquake

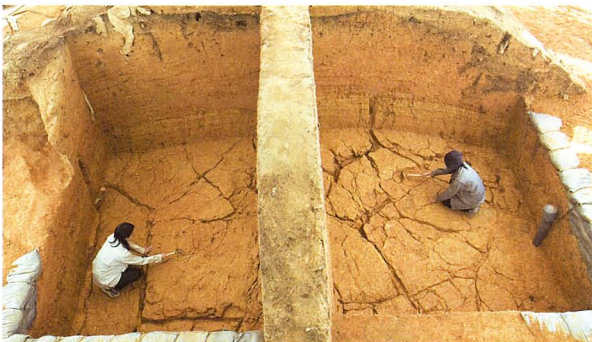
墳丘内を縦横に走る地割れ痕跡  
Earthquake traces running along the length and breadth of the mound

平成18年10月から実施している高松塚古墳の墳丘調査で、版築層を突き破る地割れを多数確認した。地割れは、墳丘の表土層直下から、墳頂下5mの石室床面にまで達し、さらに下層に連続する。こうした地割れは、近年の地震考古学の成果によると、マグニチュード8クラスの巨大地震によって生じたとみられ、奈良盆地南部を90～150年周期で襲う巨大地震、「南海地震」の痕跡と考えられる。西暦700年前後に高松塚が築かれて以降、9回の南海地震が発生しているが、墳丘の損傷がいつの地震によるものかは定かではない。石室直上で平面検出した地割れは、石室の輪郭に沿って直線的に走り、石室の隅から外側へ放射状に派生するなど、直下に位置する石室の形状を見事に映し出していた。地割れは石室の背面に回って空隙をつくり、雨水が石室へ浸透する水みちや、石室への虫の侵入経路になるなど、壁画劣化の遠因となった可能性が高い。最近の南海地震は昭和21（1946）年に発生。今世紀の前半には次の南海地震の発生が予測されている。高松塚に刻まれた地震痕跡を防災対策の教訓としなければならない。

During the excavation conducted in October 2006 at the Takamatsuzuka tomb, a number of fissures splitting the layers of tamped earth were discerned. These fissures extended from just below the surface of the mound down to the floor of the stone chamber 5 m beneath the mound's apex, and continued into the strata further below. Based on the recent fruits of earthquake archaeology, these fissures are thought to have resulted from a severe, magnitude 8-class earthquake, and are traces of the "Nankai earthquake" thought to hit the southern Nara basin on a cycle of 90 to 150 years. After the construction of the Takamatsuzuka tomb around the year 700, there have been nine recurrences of the Nankai earthquake, though it is not certain which of these caused the damage to the mound. Fissures detected at horizontal level just above the stone chamber extending along straight lines following its outlines, and radiating outward from its corners, splendidly reflecting the shape of the stone chamber just below. It is highly likely that these fissures, by creating gaps behind the chamber walls, served as pathways for rainwater and insects to penetrate the chamber, thereby contributing remotely to the deterioration of the murals. The most recent Nankai earthquake occurred in 1946. The next occurrence is expected to come in the first half of the current century. It is vital that we take lessons for measures against natural disasters from the earthquake traces found at the Takamatsuzuka tomb.

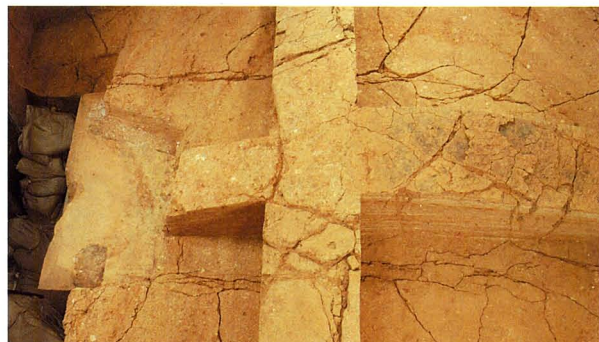
石室の輪郭を示す石室直上の地割れ  
Fissures immediately above the stone chamber, indicating its outline

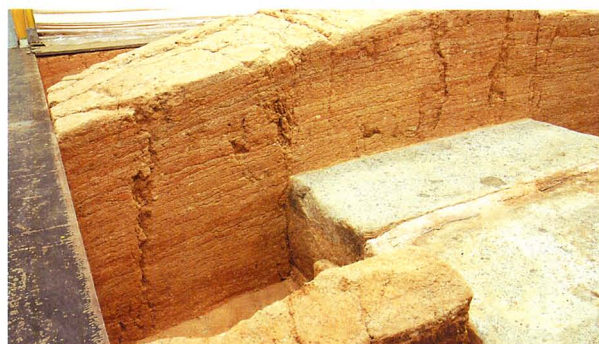
石室に沿って版築を突き破る地割れ  
Fissures following the stone chamber, splitting layers of tamped earth
