#### カンボジア：アンコール遺跡群内西トップ遺跡

#### Cambodia: Western Prasat Top, Angkor Site Group

## 独立行政法人 国立文化財機構 奈良文化財研究所概要 2020

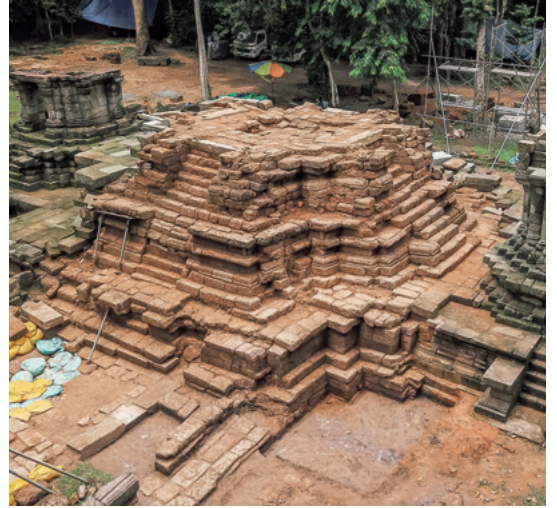
奈良文化財研究所が調査修復事業を進めている西トップ遺跡では、現在、中央祠堂の修復をおこなっています。中央祠堂外装材の砂岩を解体したところ、内側からラテライトと呼ばれる石材で構成された基壇を新たに検出しました（写真中央）。

この調査により、ラテライト基壇が先に構築され、その後にラテライト基壇をまるごと覆う形で砂岩基壇が増築されたことが判明しました。

写真は西トップ遺跡を北東から撮影したものです。

At Western Prasat Top, where the Institute has been carrying out investigations and restoration work, at present restoration is being conducted on the central shrine. Upon dismantling the sandstone used as the outer dressing material for the central shrine, on the interior a podium comprised of laterite as the material was newly discovered (at center in the photo).

Based on this investigation, it became clear that the laterite podium was built first, after which a sandstone podium was added by entirely covering over the laterite structure.

The photo was taken of Western Prasat Top from the northeast.
